Home Inspection Report

8625 Shelbyville Road
Louisville, Kentucky 40222

Inspected by:
Marty Goldsmith Kentucky License 266196
Gold Home Inspection LLC

20:48 March 04, 2022

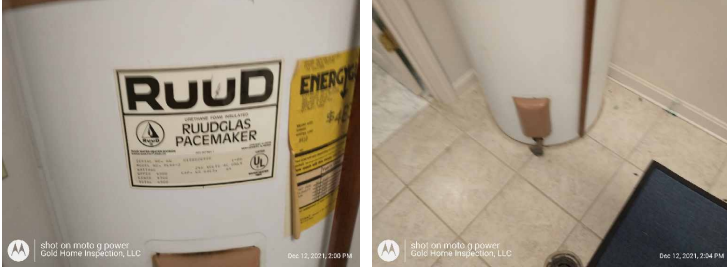
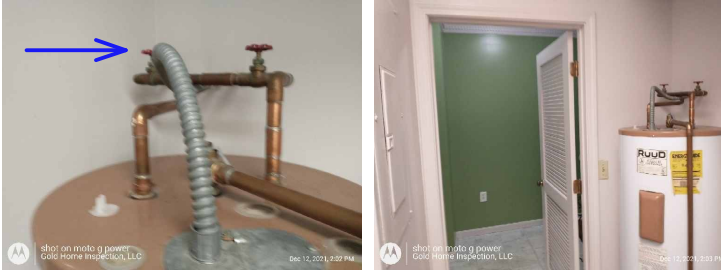
Water Heater Operation: Adequate - Unit was fully functional at time of inspection and per serial number is 33 years old. In practice I commonly see electric hot water heaters lasting a long time. Having the unit inspected by a professional plumber could better determine life and replacement time frame. Upon replacement of unit, I would consider have a drip pan installed.

Power: Noting no discount. Breaker panel is less than three feet.

Hot water heater is old

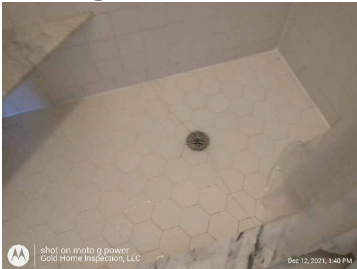
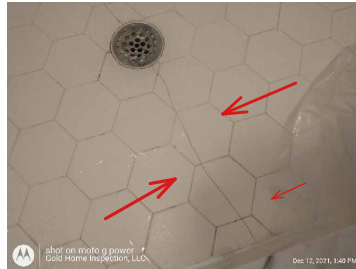
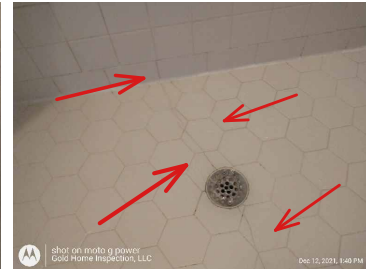
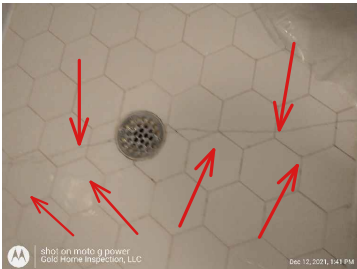
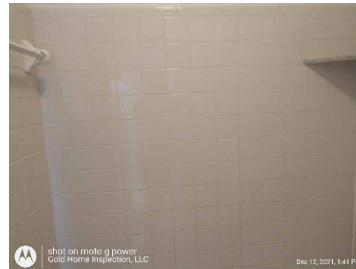
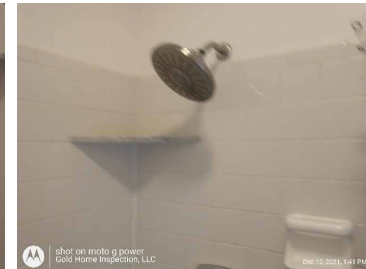
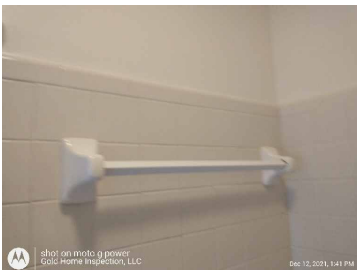
☒☐☐☐☐ Shower/Surround: Tile - Noting crack across the shower floor. No visable leakage. This could leak into unit below.

Shower has a crack that covers both sides, I let the shower run for about 15 minutes, no leaks. Inspectors concern is one day this could leak into the unit below.

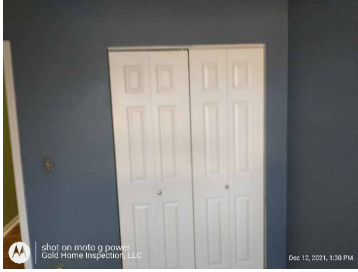
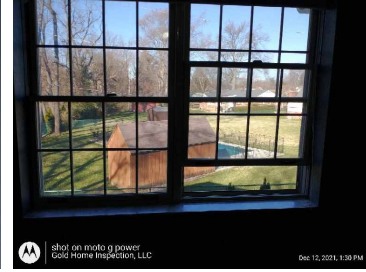
Windows: Wood - Window on right side does not hold open.

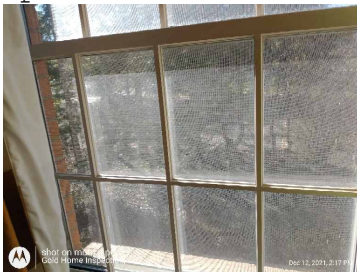
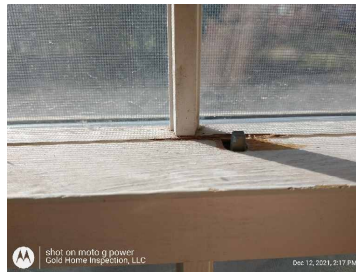
Windows: Wood - Opener missing, window frame need repair. Window not opened.

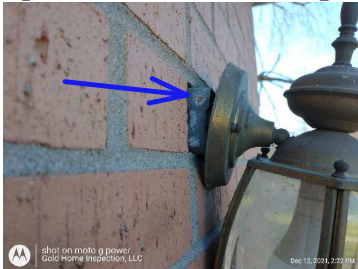
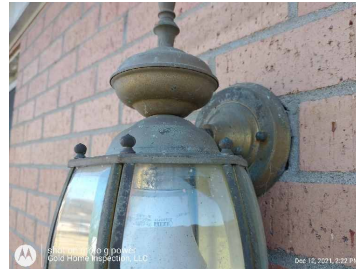
Porch light Surface mount light - One fixture is loose and should be repaired by electrician. Inspector could not locate light switch.

Light fixture on the porch needs to be repaired

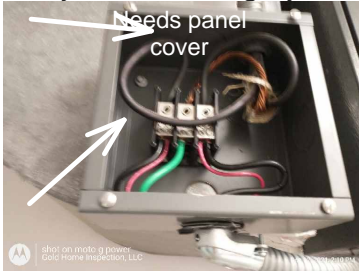
Panel cover Exposed hot wiring. Requires a cover.

1. Utility room Heating System Panel cover Exposed hot wiring. Requires a cover.

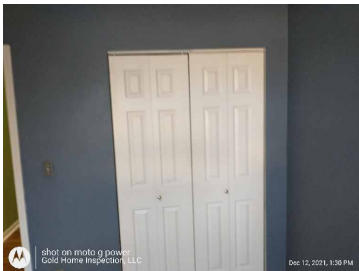
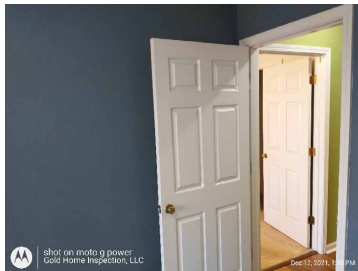
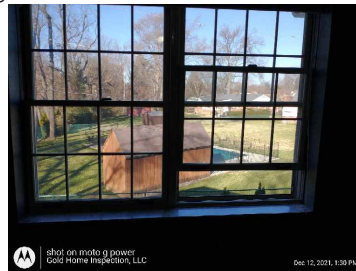
2. Master Bedroom Doors: Hollow wood - Pull out door to closet does not work.
3. Master Bedroom Windows: Wood - Neither window holds open.

4. Smaller Bedroom Windows: Wood - Window on right side does not hold open.

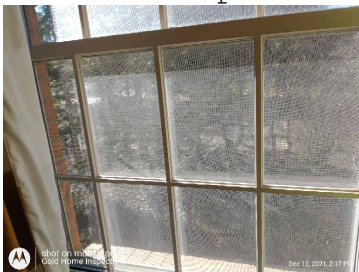
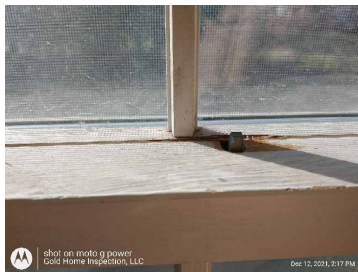
5. Dining Room Living Space Windows: Wood - Opener missing, window frame need repair. Window not opened.

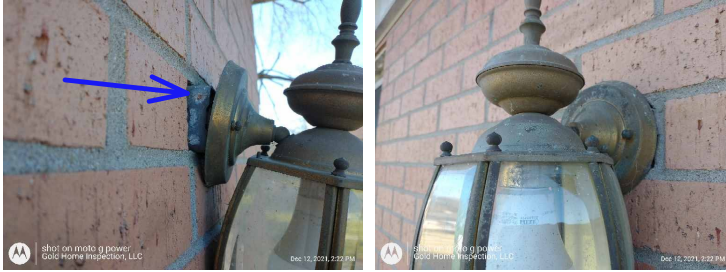
6. Patio Living Space Porch light Surface mount light - One fixture is loose and should be repaired by electrician. Inspector could not locate light switch.
