# Home Inspection Report

5807 Medtree Place  
Louisville, KY 40229

Marty Goldsmith Kentucky License 266196  
Gold Home Inspection LLC

20:43 March 04, 2022

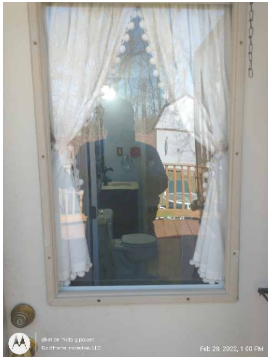
Patio Door: Wood door - Glass broken, plastic insert

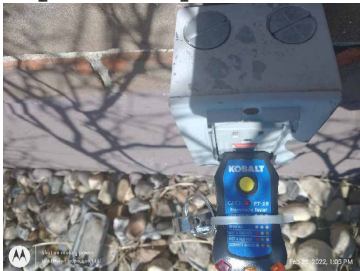
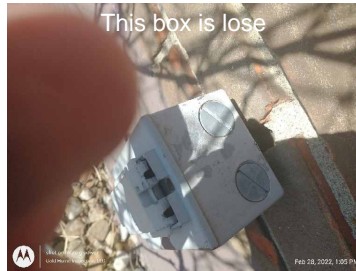
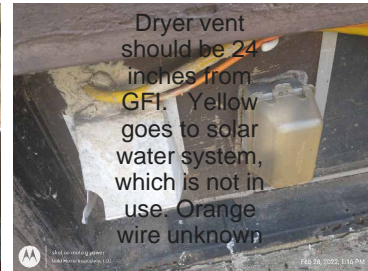
Exterior Electric Outlets: 110 VAC GFCI - Several issues, which should be repaired by licensed electrician.

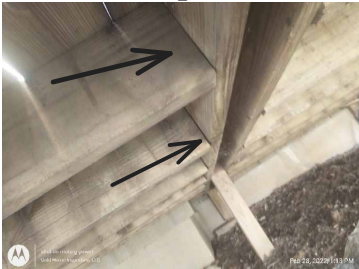
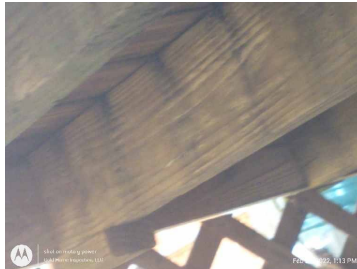
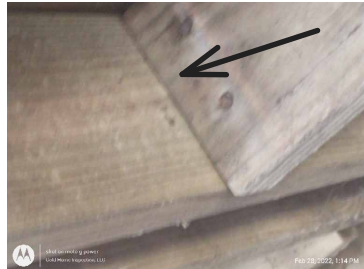
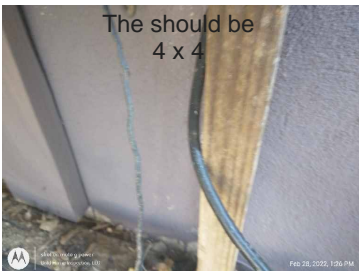
Deck Structure: Treated lumbar - Deck hangers should have been used to hold up deck joists and structure. Falling to have these will cause deck to fail. Carpenter or deck builder can install these.

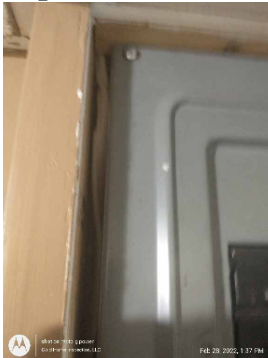
- Manufacturer: Square D - Panel was fully functional at time of inspection. Panel is original to home and 48 years old. Multiple different type of breakers have been added in. Panel is missing one screw and has two different types of screws. Two breakers have white substance on them. Recommend panel is inspected by professional electrician and any necessary repairs are followed. Score given over age.

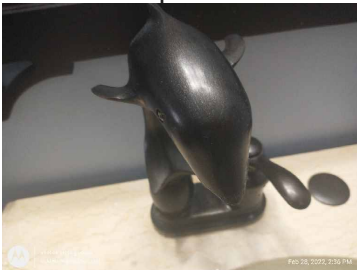
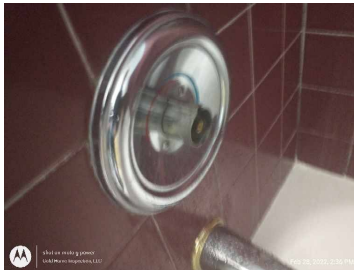
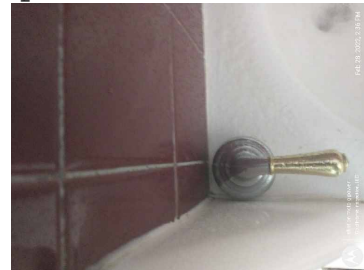
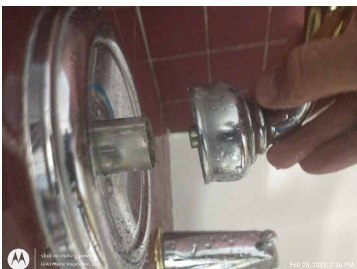
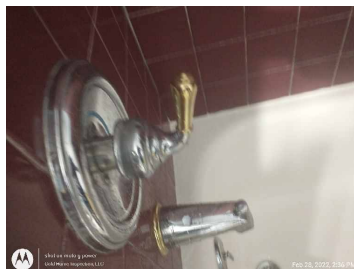
Faucets/Traps: Handle to shower needs to be repaired.

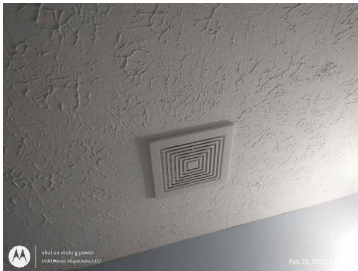
HVAC Source: None no vent in room.  
     Ventilation:

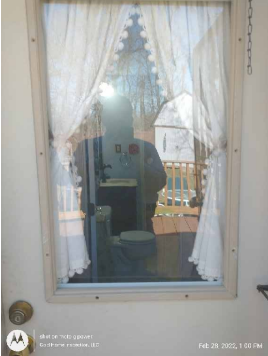
1. Patio Door: Wood door - Glass broken, plastic insert

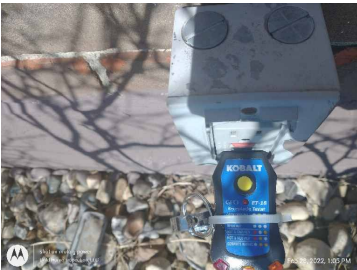
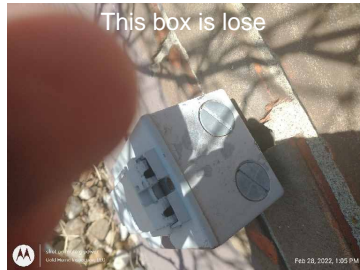
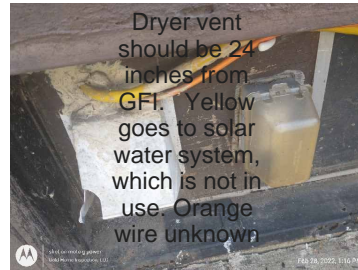
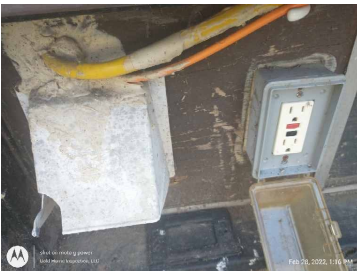
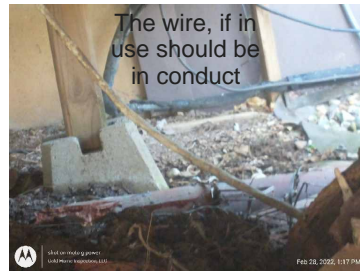
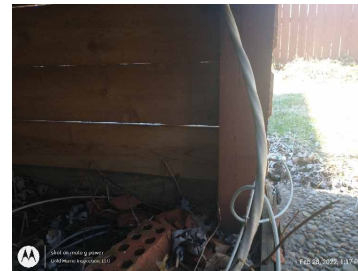
2. Exterior Electric Outlets: 110 VAC GFCI - Several issues, which should be repaired by licensed electrician.

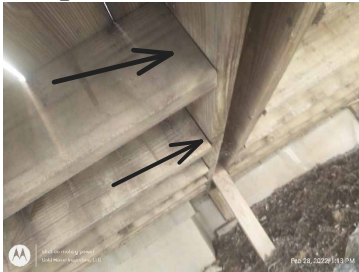
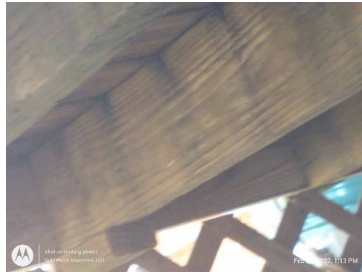
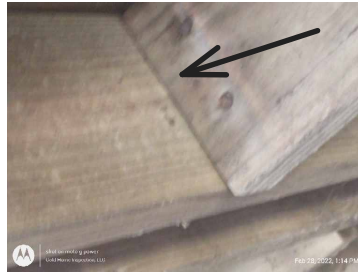
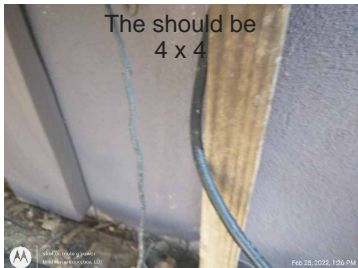
### 5. Rear Deck Deck Structure: Treated lumbar - Deck hangers should have been used to hold up deck joists and structure. Falling to have these will cause deck to fail. Carpenter or deck builder can install these.

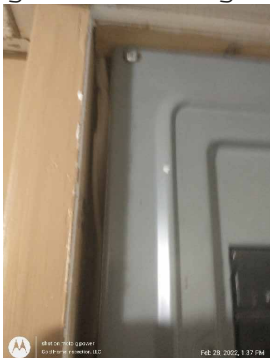
### 6. Square D Electric Panel Manufacturer: Square D - Panel was fully functional at time of inspection. Panel is original to home and 48 years old. Multiple different type of breakers have been added in. Panel is missing one screw and has two different types of screws. Two breakers have white substance on them. Recommend panel is inspected by professional electrain and any necessary repairs are followed. Score given over age.

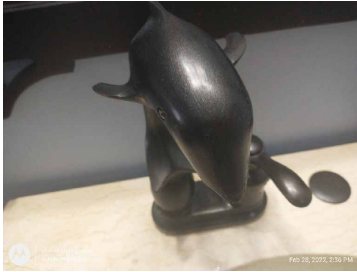
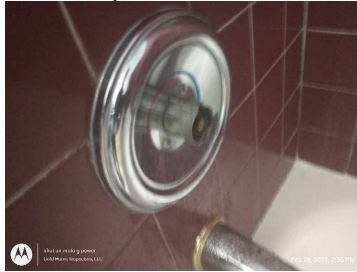
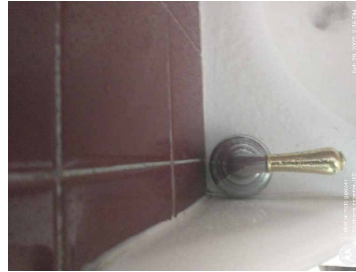
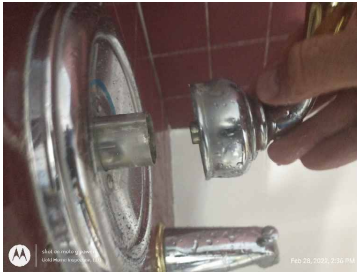
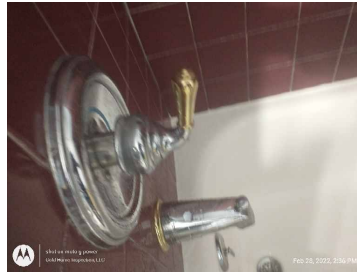
8. 1st floor main Bathroom Faucets/Traps: Handle to shower needs to be repaired.
