# Home Inspection Report

Marty Goldsmith Kentucky License 266196  
Gold Home Inspection LLC

20:45 March 04, 2022

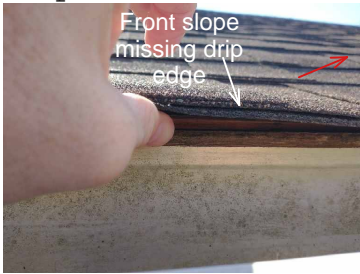
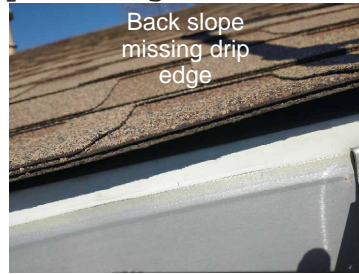
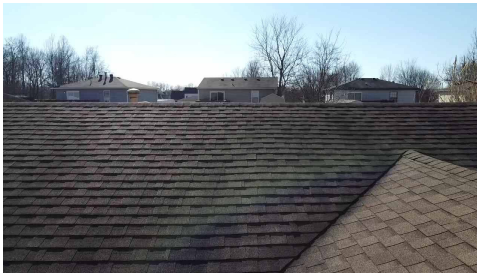
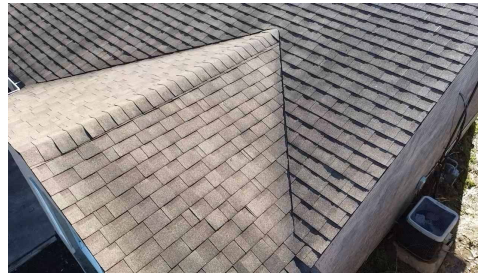
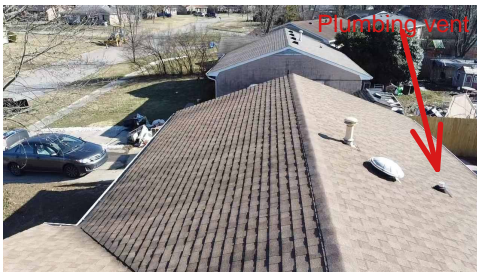
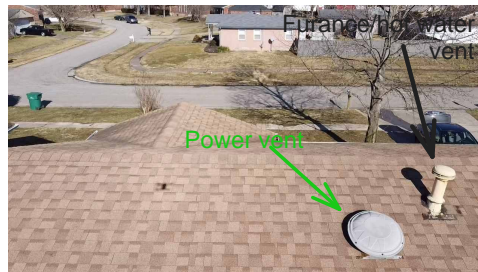
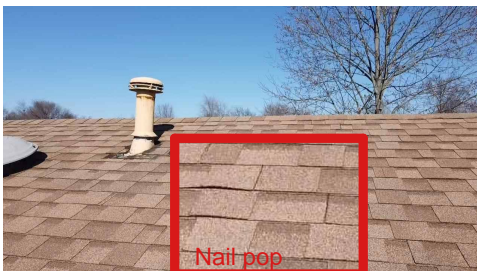
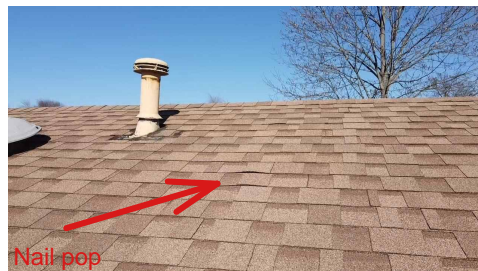
- Material: Asphalt shingle - Roof has considerable life remaining. Two issues, no drip edges installed. Drip edge support shingles at the edge of the roof where the meet gutters. Shingles along the perimeter will fail if they do not have this. Vents, house has a power vent, which is electrical powered with a thermostat, testing these units is very difficult and you have no way to know if they work. Box vents are a simple solution that provide good air flow and limited service.

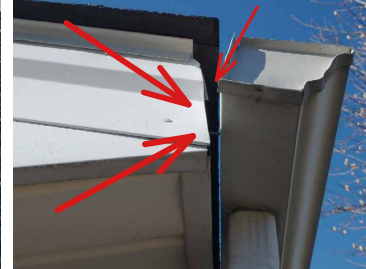
Gutters: Aluminum - Front corner at driveway gutter needs to be properly mounted to structure.

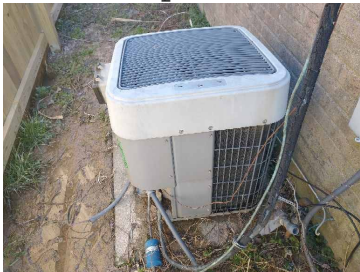
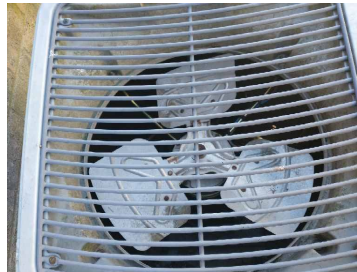
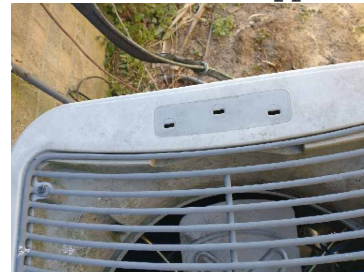
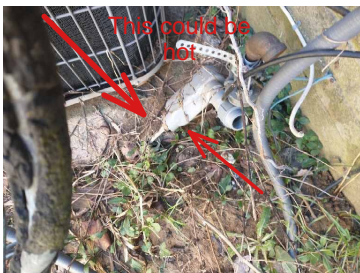
A/C System Operation: Not inspected - Home inspection standards require that central air unit not be operated when Temperature is below 65 degrees. On February 17 and February 18th. I visited this house and did not tested the unit. The unit is 19 years old and typical life of these products in the 15 year range. I would recommend that buyer plan to replace the unit. Exposed electric line near the unit needs to be capped.

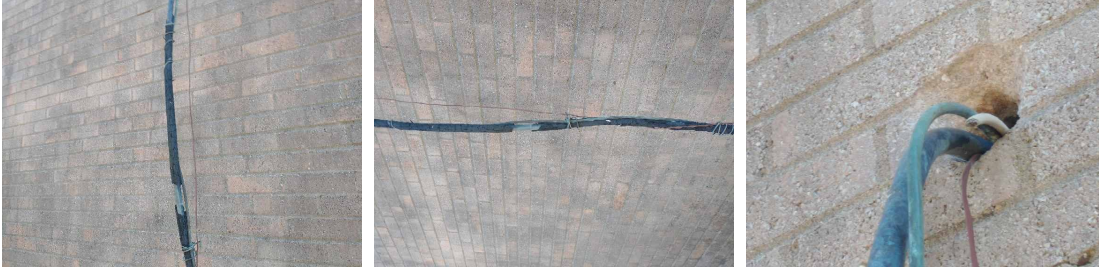
Refrigerant Lines: Suction line and liquid line - Entry point not sealed

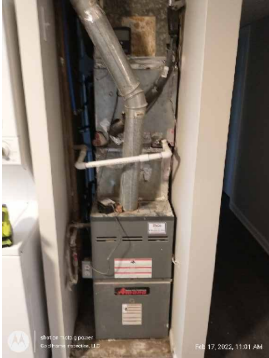
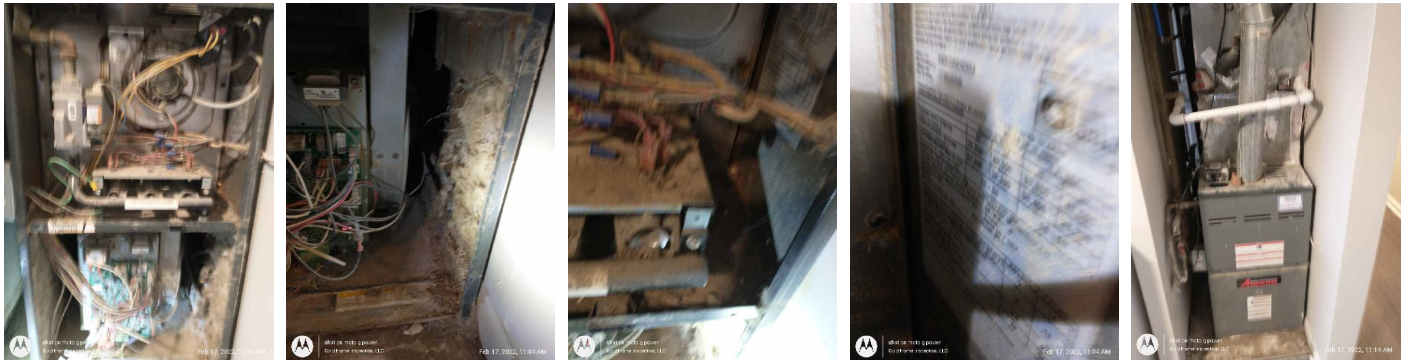
Heating System Operation: Adequate - Unit was made in 2011 and working at time of inspection. No place for filter and the unit is very dirty. Recommend proper mounts be installed for filter and unit be cleaned. Property owner needs to educate future renters of need to change filters. I recommend they are changed monthly and on the day LGE bills arrive. Furnace needs to be cleaned and serviced.

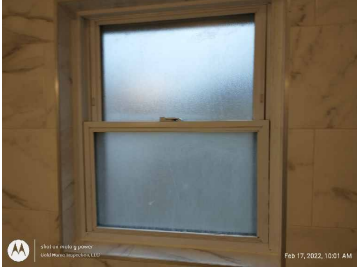
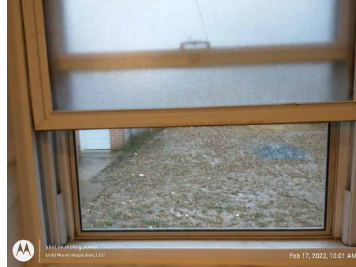
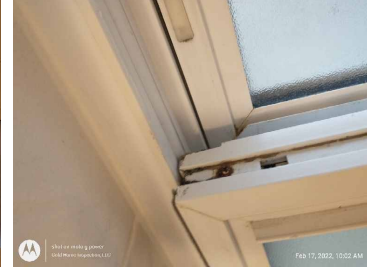
Windows: Vinyl double hung - Missing hardware on left side.

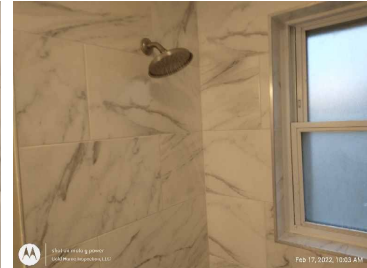
Faucets/Traps: Bath tub spicket needs to be tighten and sealed.

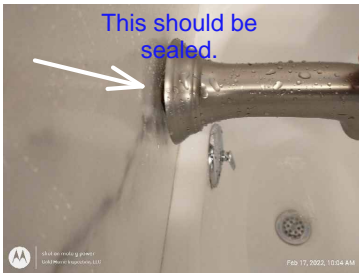
1. 1st floor main Bathroom Faucets/Traps: Bath tub spicket needs to be tighten and sealed.

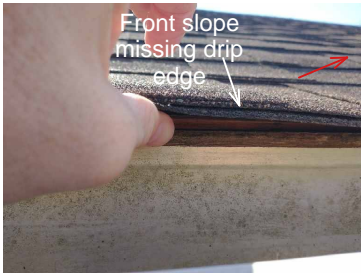
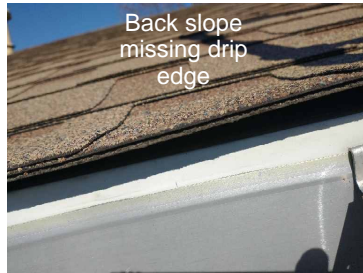
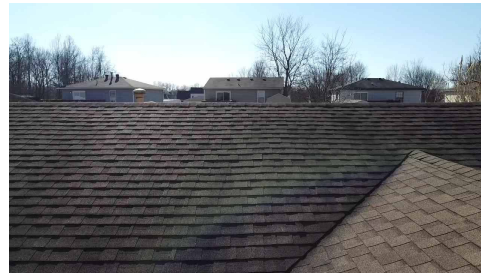
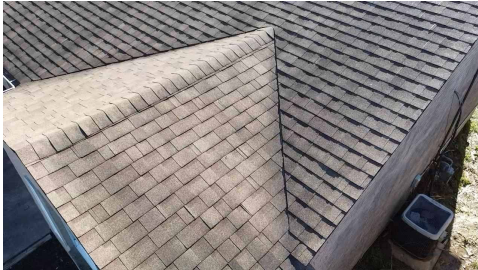
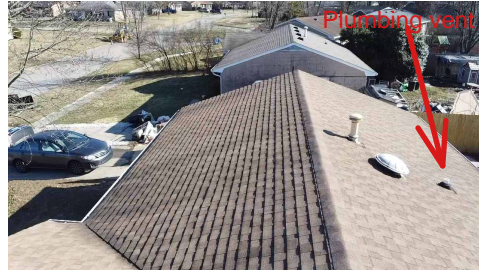
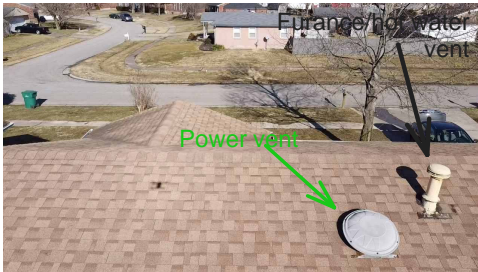
1. Main Roof Surface Material: Asphalt shingle - Roof has considerable life remaining. Two issues, no drip edges installed. Drip edge support shingles at the edge of the roof where the meet gutters. Shingles along the perimeter will fail if they do not have this. Vents, house has a power vent, which is electrical powered with a thermostat, testing these units is very difficult and you have no way to know if they work. Box vents are a simple solution that provide good air flow and limited service.

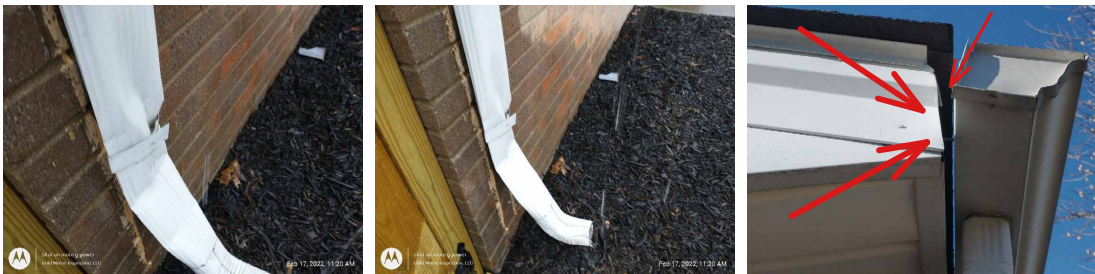
- 2. Gutters: Aluminum - Front corner at driveway gutter needs to be properly mounted to structure.

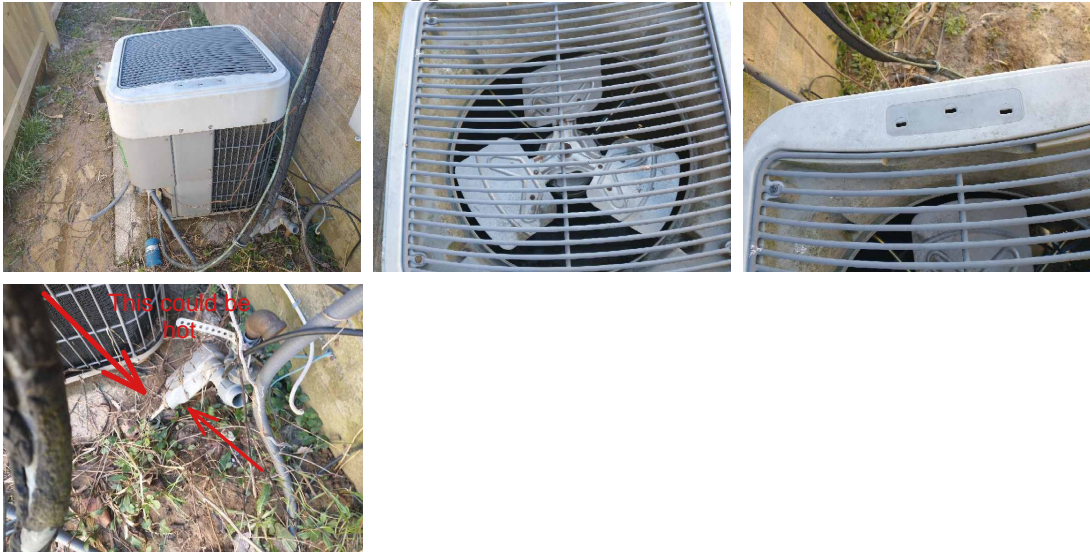
4. Main AC System A/C System Operation: Not inspected - Home inspection standards require that central air unit not be operated when Temperature is below 65 degrees. On February 17 and February 18th. I visited this house and did not tested the unit. The unit is 19 years old and typical life of these products in the 15 year range. I would recommend that buyer plan to replace the unit. Exposed electric line near the unit needs to be capped.

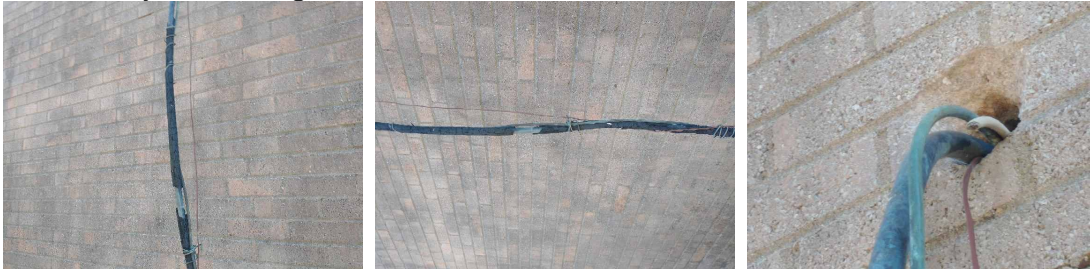
5. Main AC System Refrigerant Lines: Suction line and liquid line - Entry point not sealed

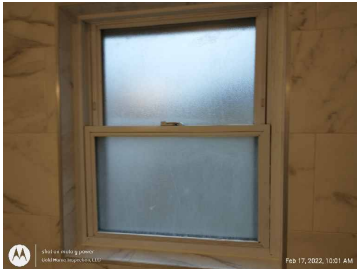
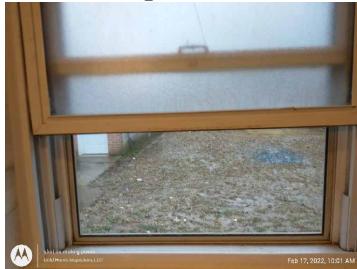
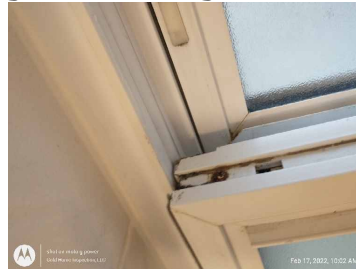
8. 1st floor main Bathroom Windows: Vinyl double hung - Missing hardware on left side.
