Home Inspection Report

4006 Dover Court
Louisville, Kentucky 40216

Marty Goldsmith Kentucky License 266196
Gold Home Inspection LLC

20:52 March 04, 2022

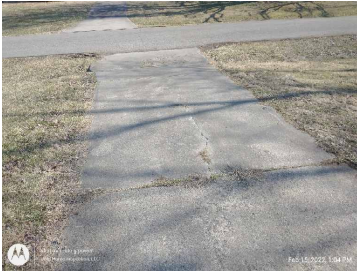
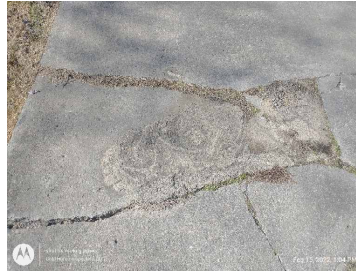
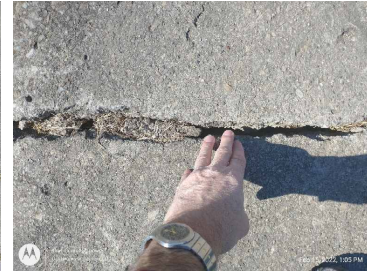
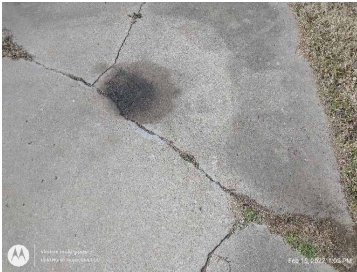
Driveway: Concrete - Suggest caulking with masonry caulk to repair crack in drive.

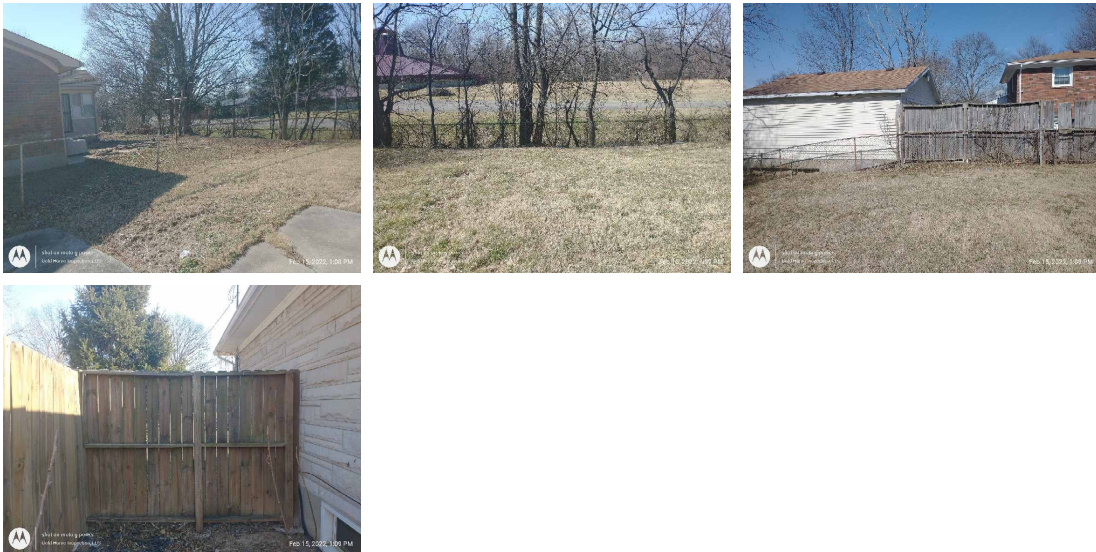
Grading: Flat
Yard Large hole - Safety issue and should be filled in.

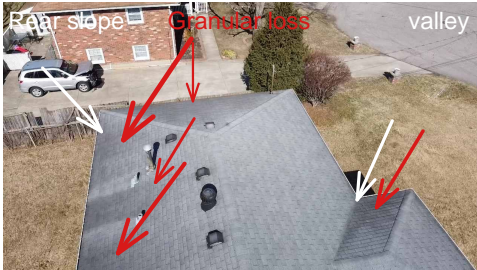
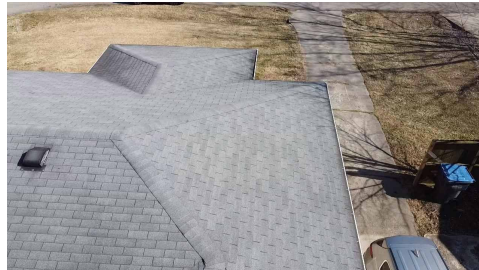
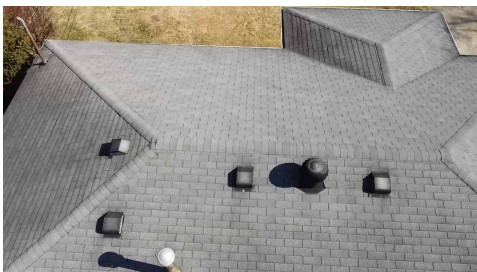
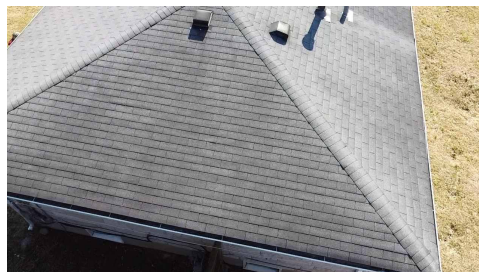
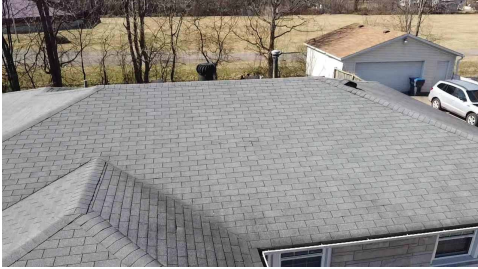
Material: Asphalt shingle 15 year. Roof has no current leakage. Good vents. Granular loss is present, along with some nail pops. Buyer should plan to replace roof in the next few years and be prepared for repairs, as needed. Buyer should also check with homeowners to see if roof meets coverage standards. Defective score given over age and condition of rear slope.

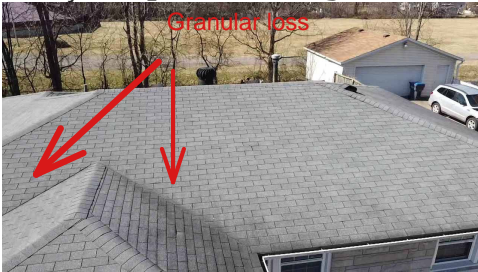
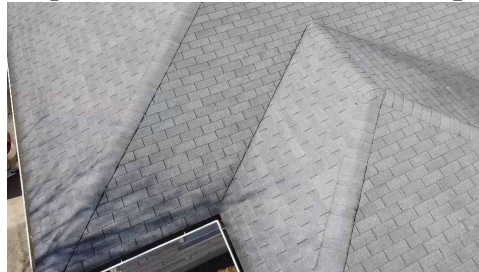
Valleys: Asphalt shingle - Valley are one of the first places roofs fail.

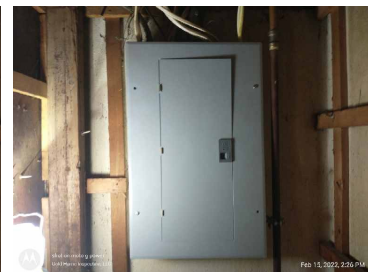
Basement Electric Panel

- Manufacturer: GE - Per electrical code wiring should not be spliced in panel.

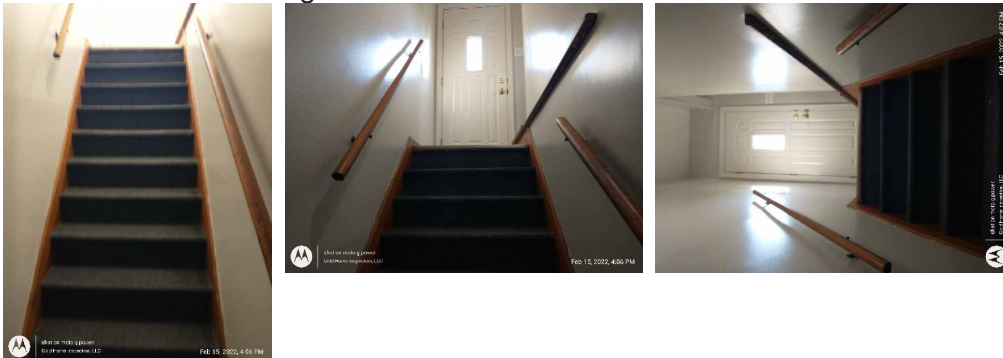
Basement Stairs/Railings: Wood stairs with wood handrails - No basement door.

Basement does not have door.

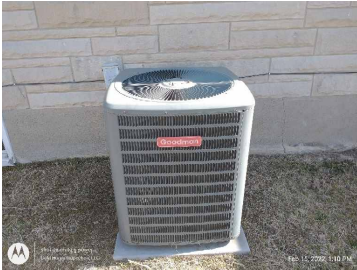
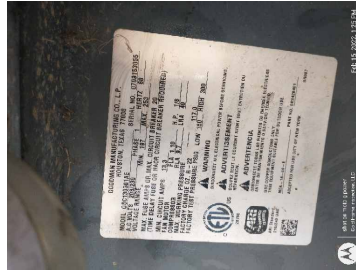
Main AC System

A/C System Operation: Outdoor range was below the normal operating Temperature and not tested. Based upon 15 year age and brand this unit in near the end of its life and homeowner should budget for replacement. Defective score given for age.

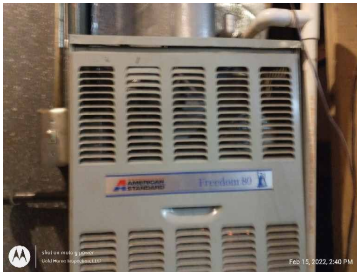
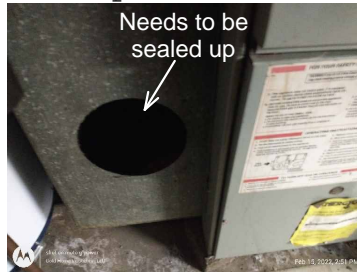
Main Heating System

- Heating System Operation: Adequate - Unit is 26 years old. Service life of these is between 25-40 years. Unit functioned at time of inspection. Filters should be changed monthly and unit should be serviced and cleaned on annual basis. Open vent needs to be sealed.

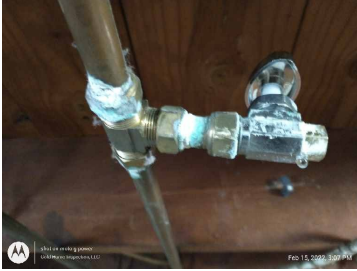
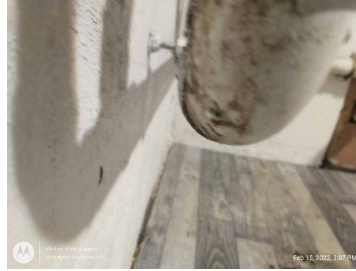
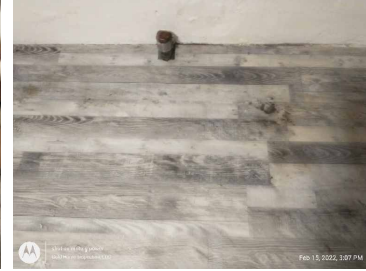
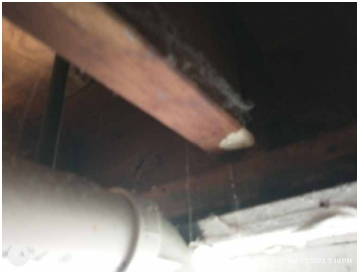
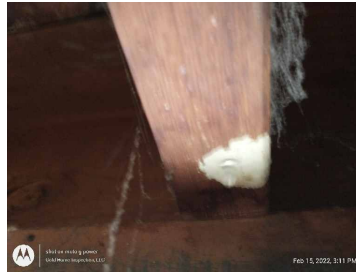
Pipes in wash room Leaks present - Several leaks present in basement, Repairs recommended by plumber.

Water leaks are noted in multiple pipes below the sink and require plumbing repairs.

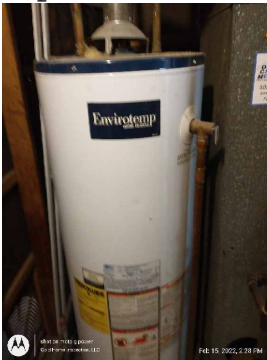
Basement Water Heater

Water Heater Operation: Adequate - Unit functioning at time of inspection. Common life spans are 15-20 years and homeowner should plan for replacement of this unit.

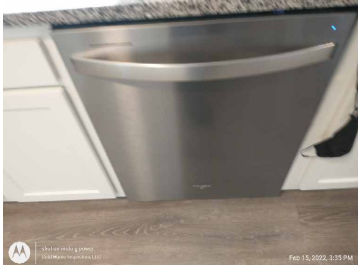
Dishwasher: Whirlpool - Noting water leak in basement

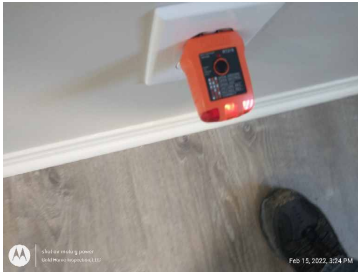
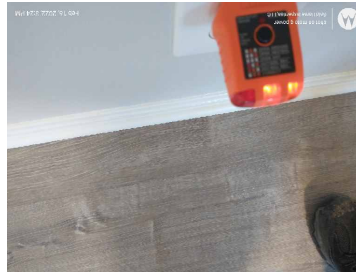
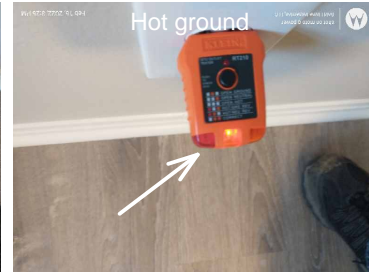
- Electrical: One wallplug shows hot ground and needs to be repaired by electrician.

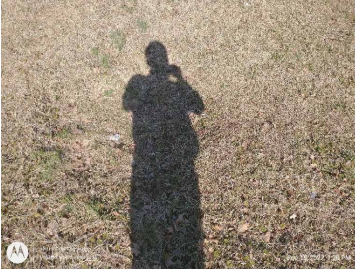
1. Yard Large hole - Safety issue and should be filled in.

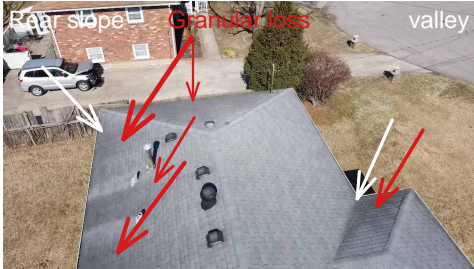
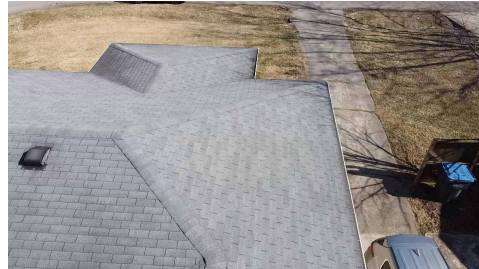
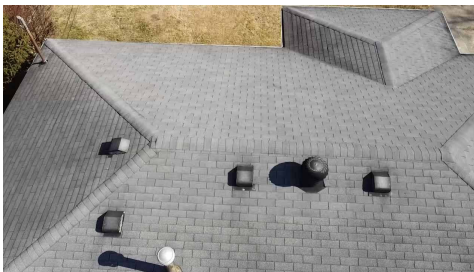
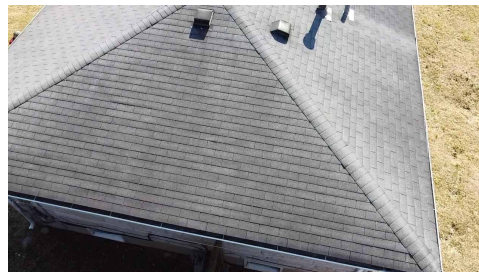
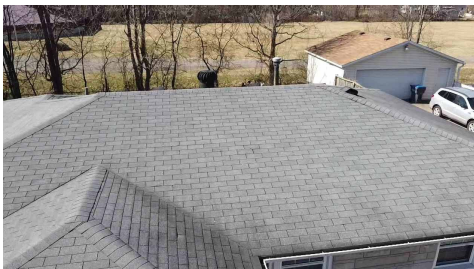
2. Main Roof Surface Material: Asphalt shingle 15 year. Roof has no current leakage. Good vents. Granular loss is present, along with some nail pops. Buyer should plan to replace roof in the next few years and be prepared for repairs, has needed. Buyer should also check with homeowners to see if roof meets coverage standards. Defective score given over age and condition of rear slope.

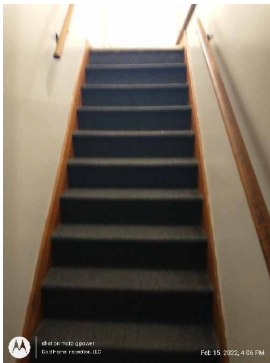
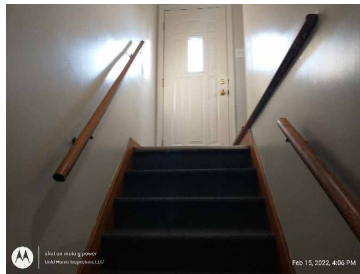
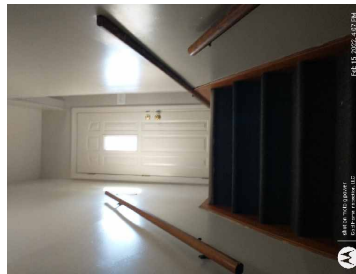
4. Bedroom Basement Basement Stairs/Railings: Wood stairs with wood handrails - No basement door.

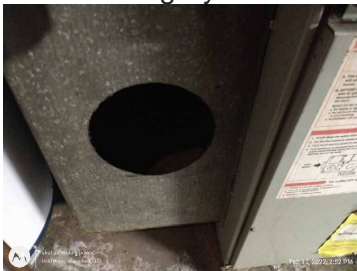
6. Main Heating System Distribution: Metal duct

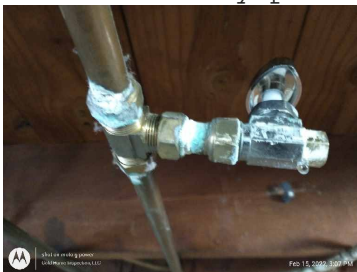
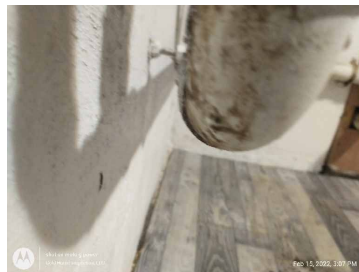
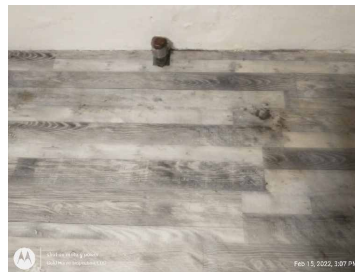
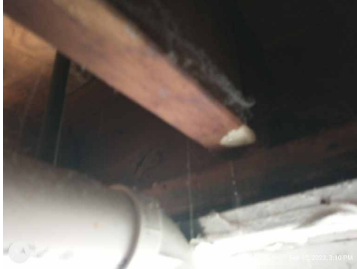
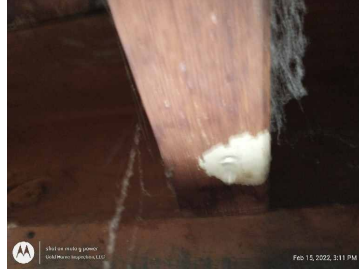
7. Pipes in wash room Leaks present - Several leaks present in basement, Repairs recommended by plumber.

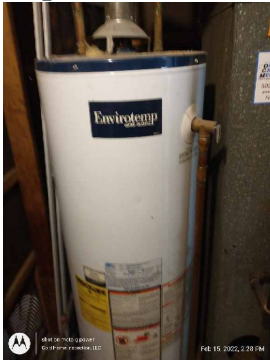
8. Basement Water Heater Water Heater Operation: Adequate - Unit functioning at time of inspection. Common life spans are 15-20 years and homeowner should plan for replacement of this unit.

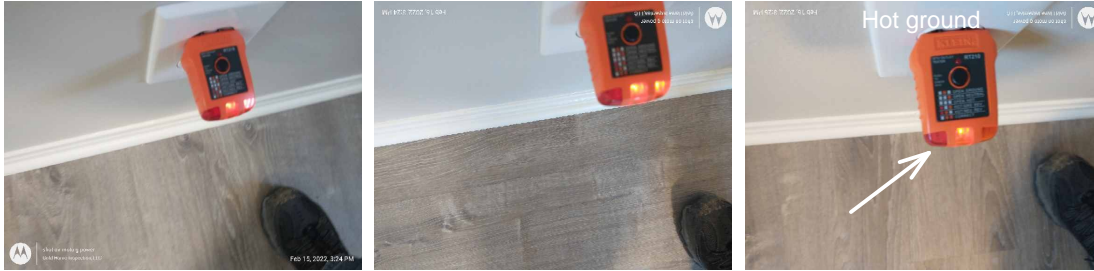
11. Front center Bedroom Electrical: One wallplug shows hot ground and needs to be repaired by electrician.
