# Home Inspection Report

14302 Lake Forest Drive  
Louisville, KY 40245

Marty Goldsmith Kentucky License 266196  
Gold Home Inspection LLC

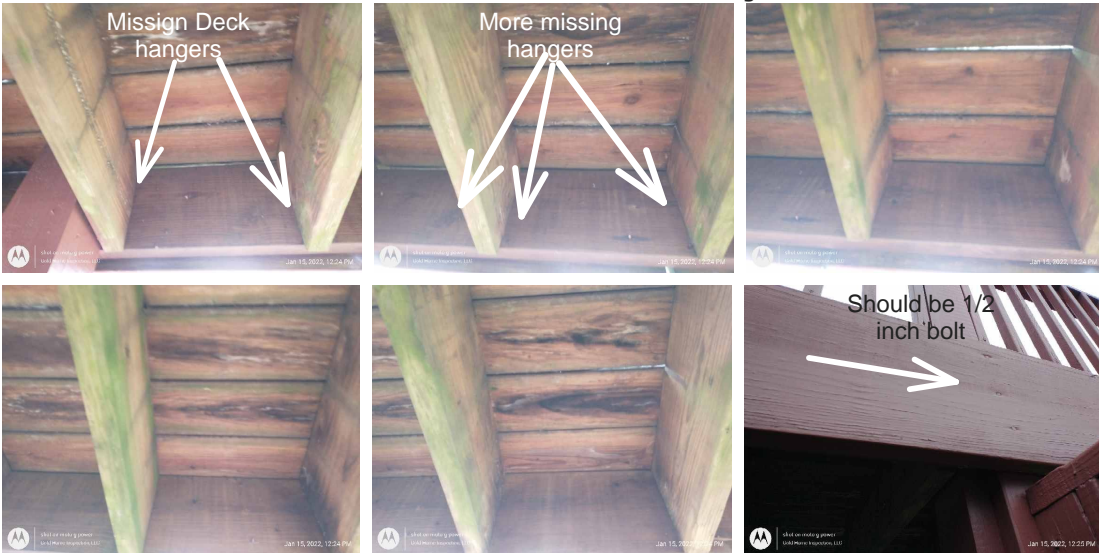
Deck Boards: Deck problems - Missing or wrong size deck hangers. Missing lag bolts, these 1/2 bolts are designed to hold a considerable weight, using small nails or bolts will lead to a failure. Missing ledger bolts and washers, repair using a board to try and support ledger board is not to code and will not work. Insured carpenter or handyman should repair the deck. Complete repairs will prolong the life of the deck. Decks are the number one source of home injuries.

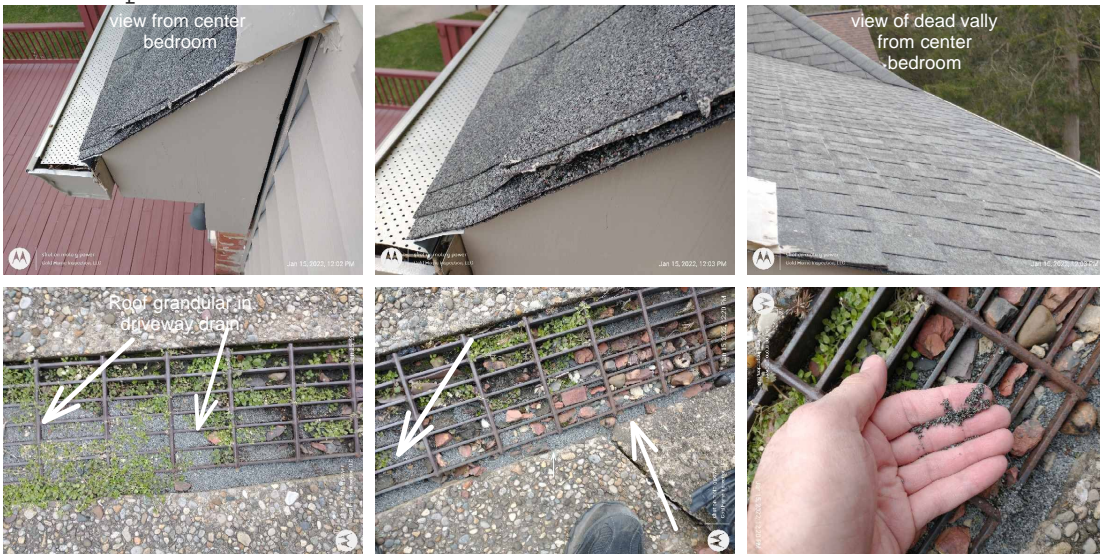
Material: ROOF - Very difficult to estimate the age of the roof. We have pictures of shingles coming up on the front slope, above the living room windows, about five feet from the gutter. We have pictures of a small leak in the center bedroom. The ceiling in this room is painted white, while other second floor ceilings are painted yellow and this makes finding leaks very difficult. These issues should be repaired by an insured roofing contractor. We also have missing glandular and missing shingles, which we have pictures of, the roof should have had installed rolled roofing in the dead valley and over the second floor bedrooms. The roof is aging, has incorrect products installed and following recommendations from a roofing contractor, would be in the best interest of the purchaser.

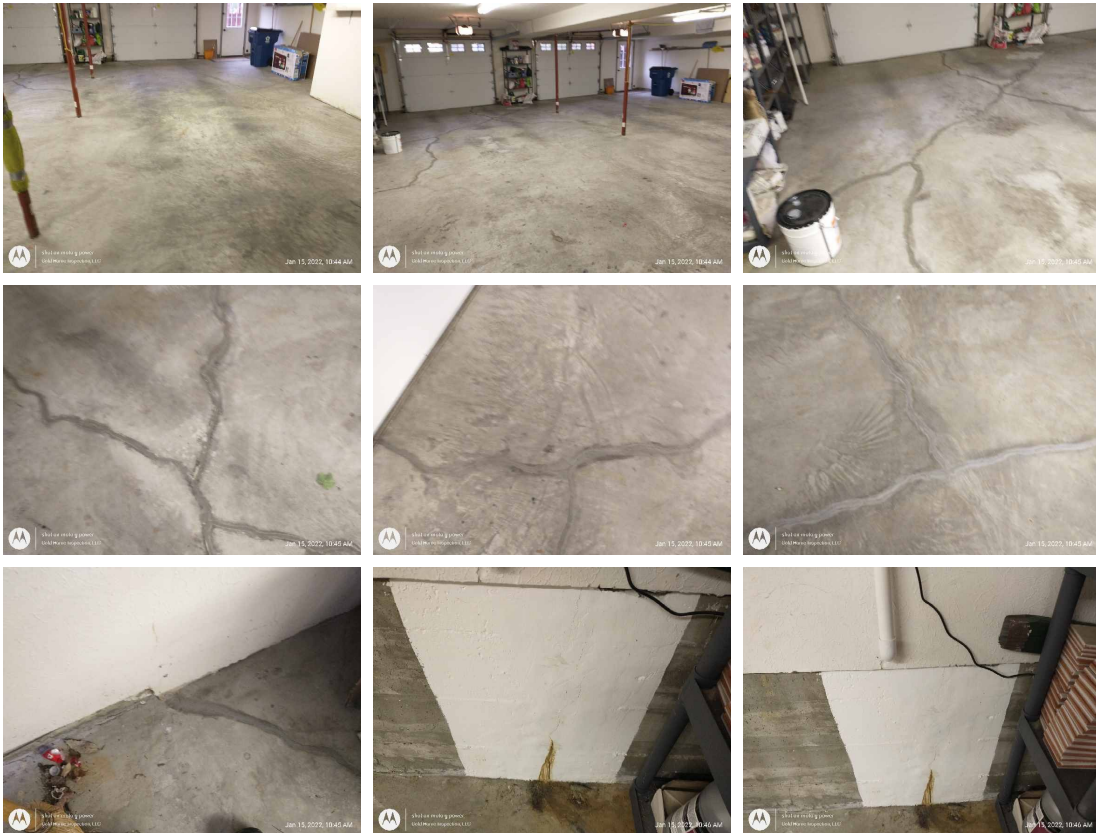
Floor/Foundation: Floor has cracking and has been repaired. Homeowner should monitor this situation.

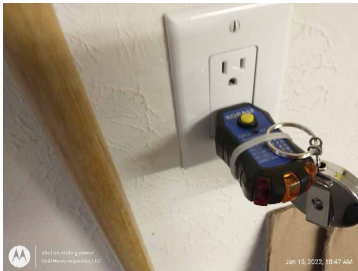
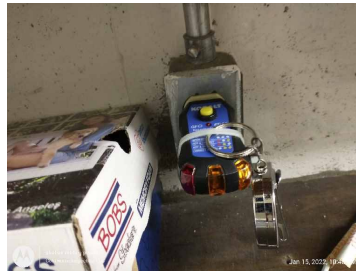
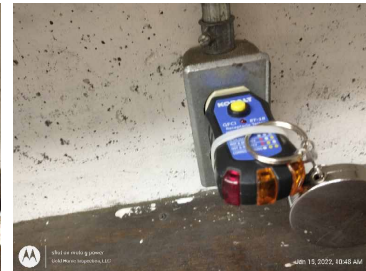
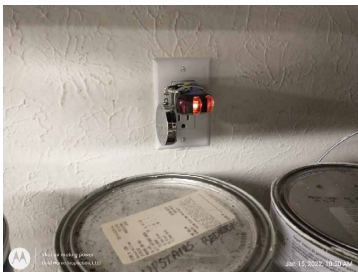
Electrical: 110 VAC - Wallplugs do not work. Repair be electrain recommended.

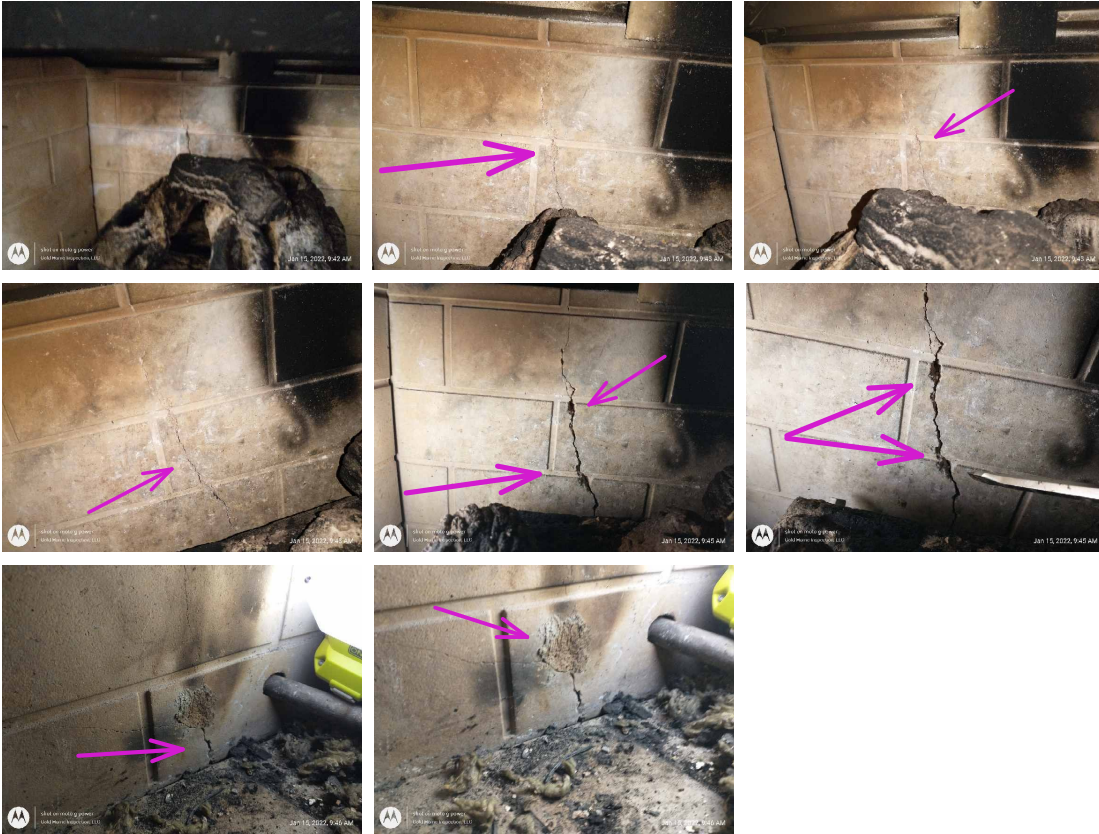
Smoke Chamber: Metal - Needs repair prior to use

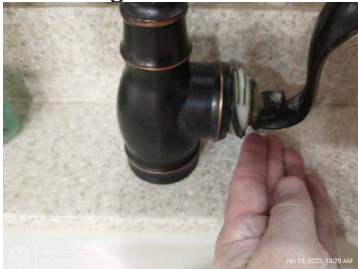
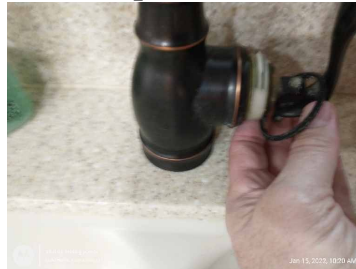
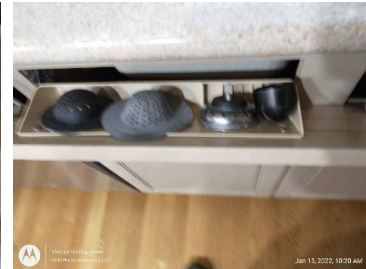
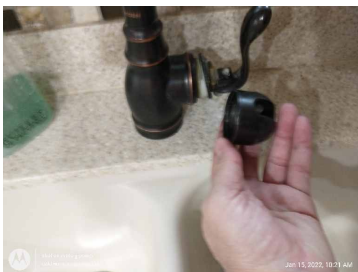
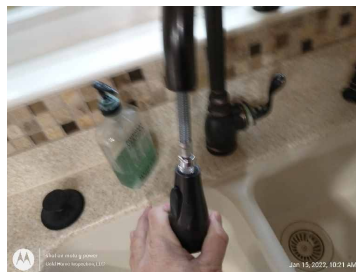
Plumbing/Fixtures: Facet needs repair.

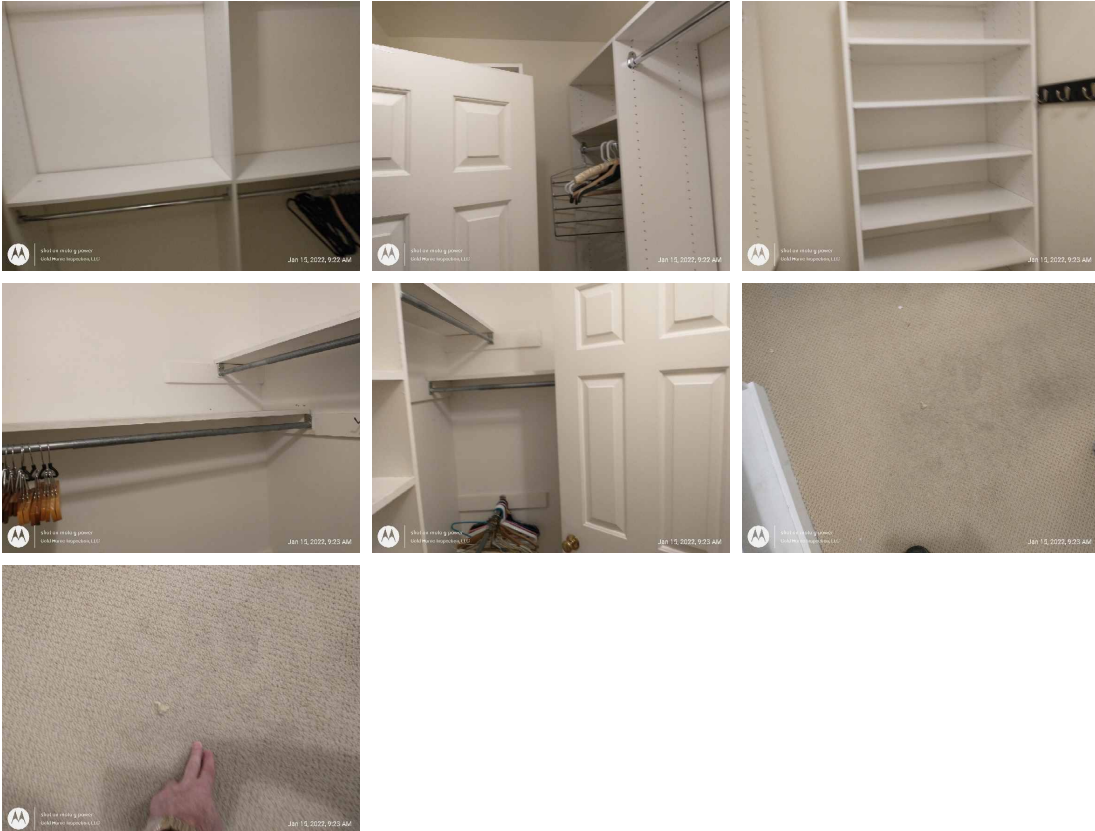
Closet: Walk In - Two walk ins, very nice. Noting carpet wear at entrance to left side closet.

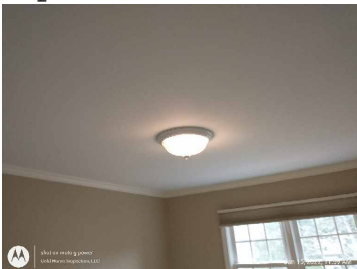
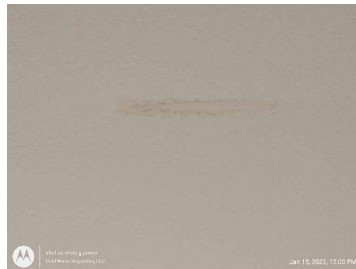
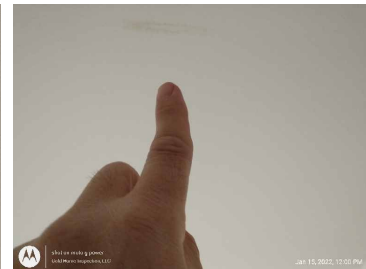
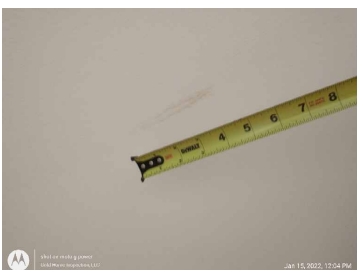
Ceiling: Paint - Water stains present. This will worsen until roof is repaired.

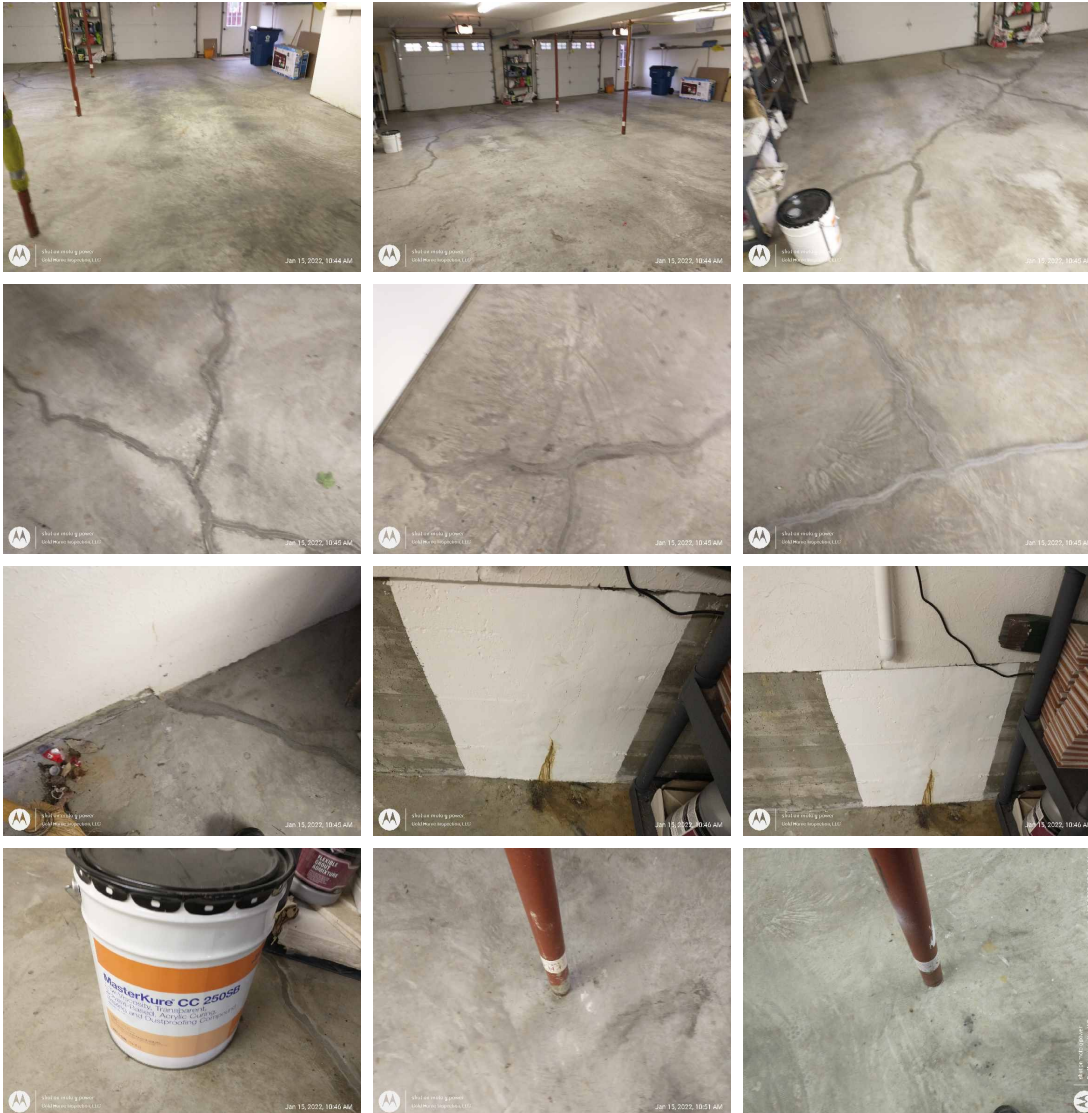
1. Attached Garage Floor/Foundation: Floor has cracking and has been repaired. Homeowner should monitor this situation.

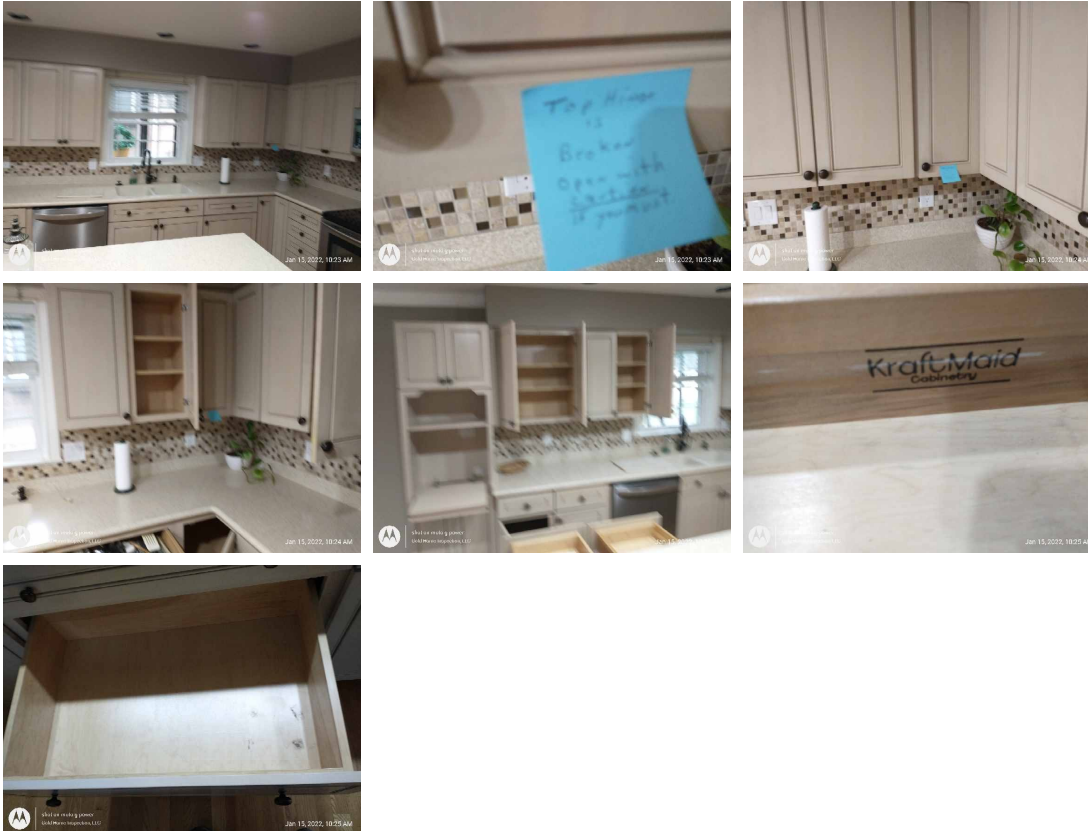
3. 1st Floor Kitchen Cabinets: Wood - Lazy susan on the upper cabinets needs a hinge remounted. This is a handyman type of work.

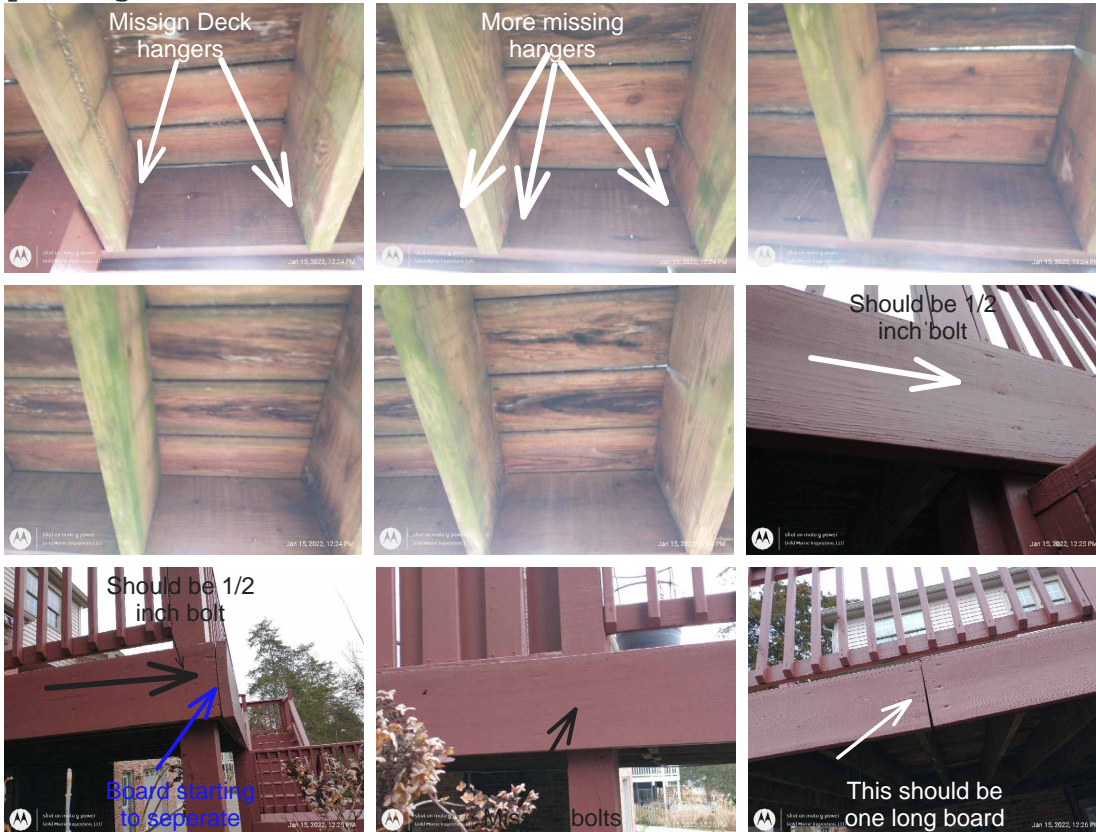
- 1. Main Deck Deck Boards:** Deck problems - Missing or wrong size deck hangers. Missing lag bolts, these 1/2 bolts are designed to hold a considerable weight, using small nails or bolts will lead to a failure. Missing ledger bolts and washers, repair using a board to try and support ledger board is not to code and will not work. Insured carpenter or handyman should repair the deck. Complete repairs will prolong the life of the deck. Decks are the number one source of home injuries.

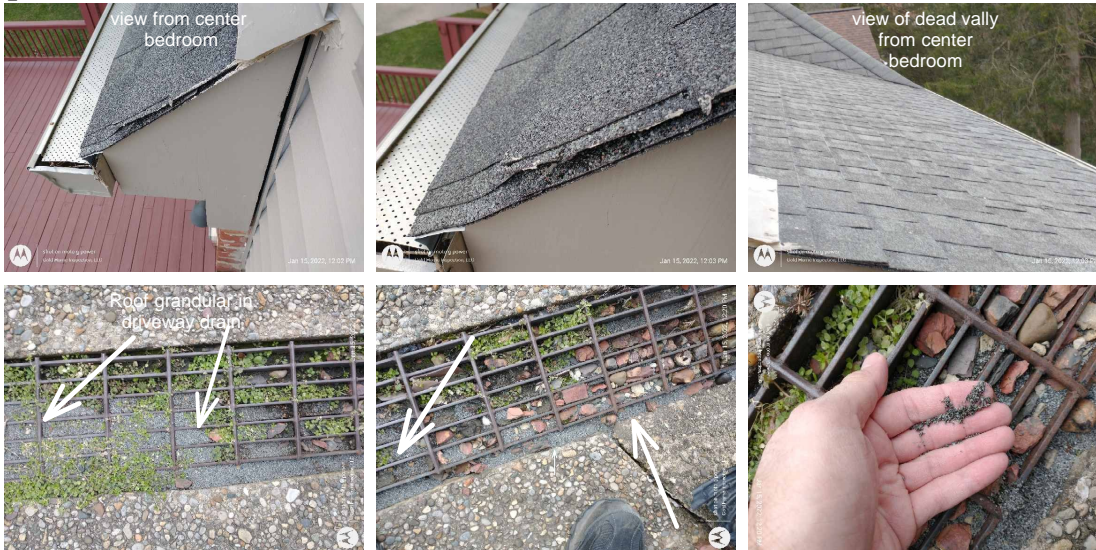
4. All Roof Surface Material: ROOF - Very difficult to estimate the age of the roof. We have pictures of shingles coming up on the front slope, above the living room windows, about five feet from the gutter. We have pictures of a small leak in the center bedroom. The ceiling in this room is painted white, while other second floor ceilings are painted yellow and this makes finding leaks very difficult. These issues should be repaired by an insured roofing contractor. We also have missing glandular and missing shingles, which we have pictures of, the roof should have had installed rolled roofing in the dead valley and over the second floor bedrooms. The roof is aging, has incorrect products installed and following recommendations from a roofing contractor, would be in the best interest of the purchaser.

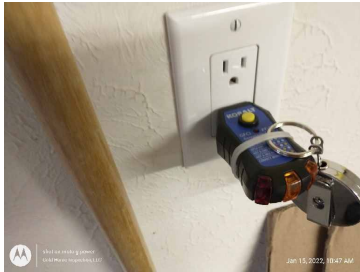
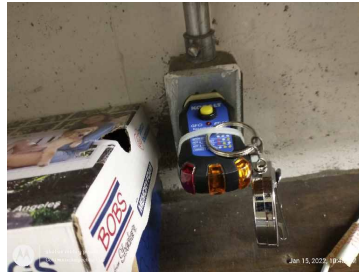
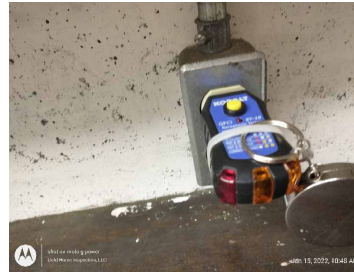
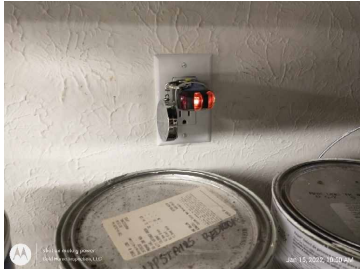
5. Attached Garage Electrical: 110 VAC - Wallplugs do not work. Repair be electrain recommended.

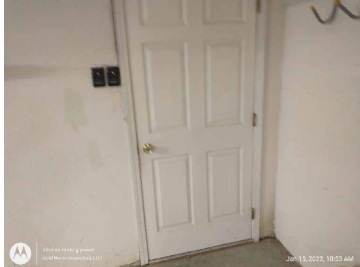
6. Attached Garage Smoke Detector:  
7. Attached Garage Basement door Hollow wood - This should be fire rated door.

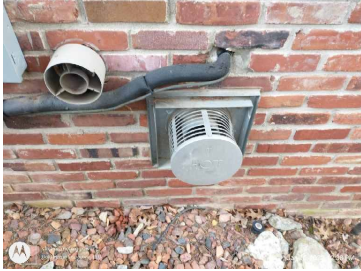
8. Side of house AC System Refrigerant Lines: Low pressure and high pressure - This should be routed away from the fireplace

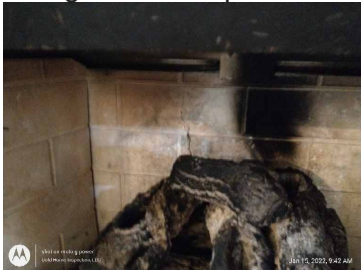
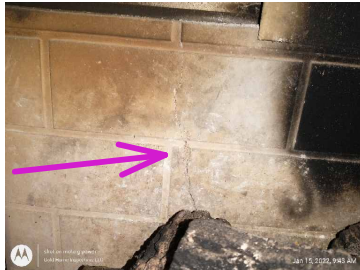
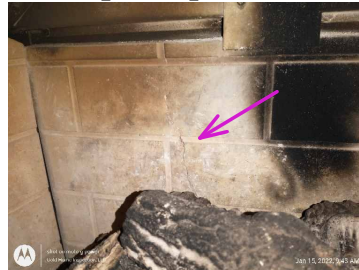
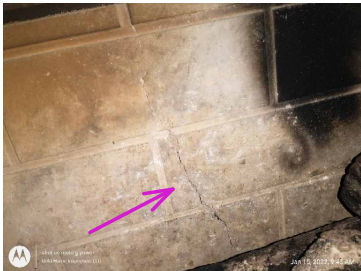
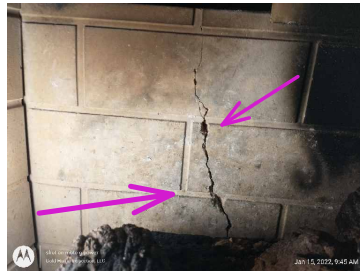
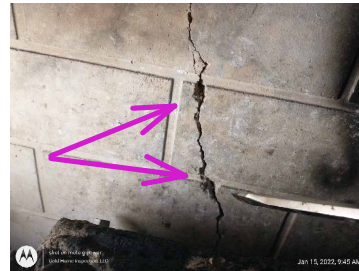
9. Living Room Fireplace Smoke Chamber: Metal - Needs repair prior to use

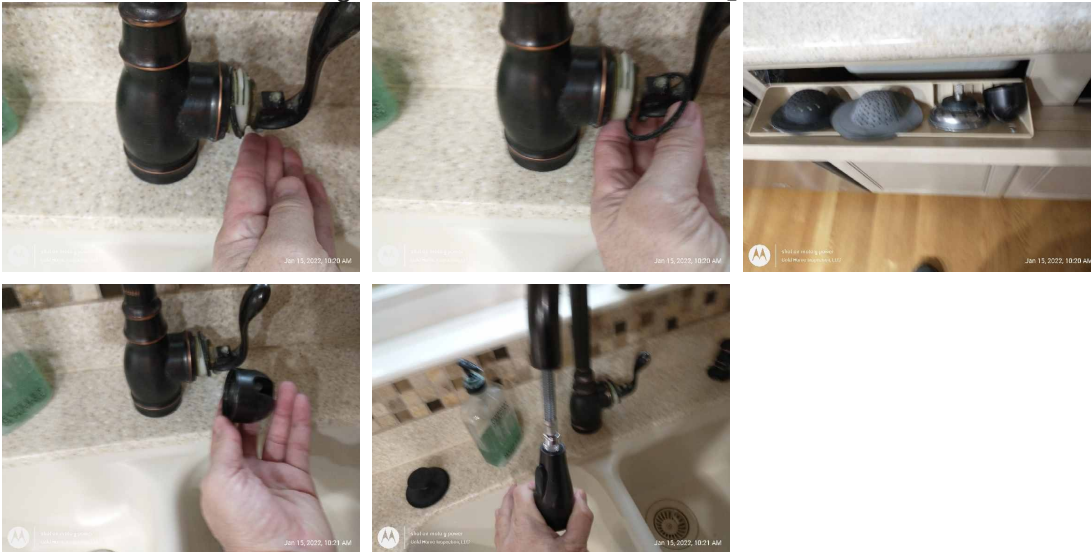
11. 1st Floor Kitchen Plumbing/Fixtures: Facet needs repair.

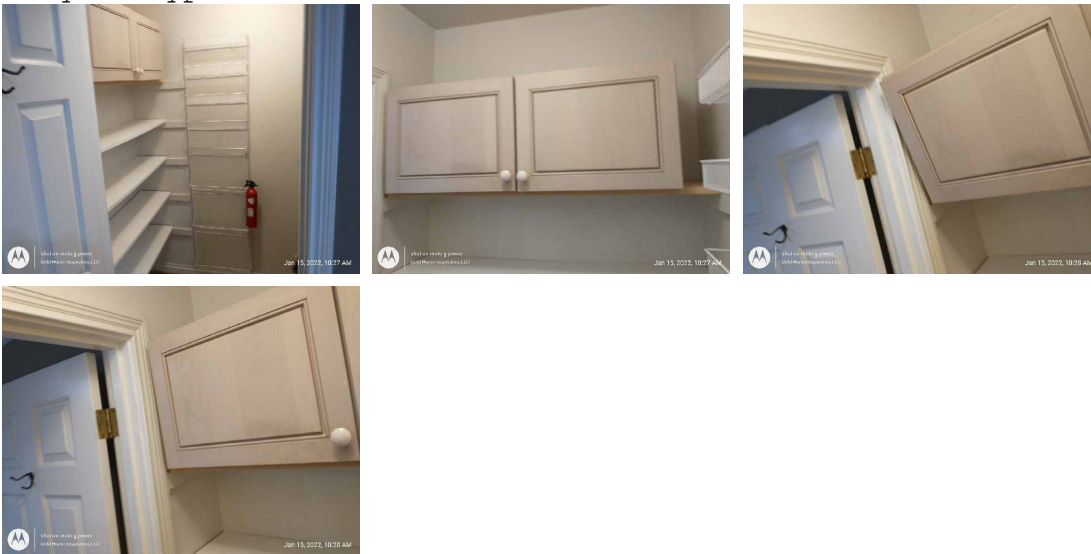
12. 1st Floor Kitchen Pantry: Large - Cabinet is not mounted and needs to be secured. Handyman type issue.
