# Home Inspection Report

2317 Mayo Drive  
Prospect, KY 40059

Inspected by:  
Marty Goldsmith  
Gold Home Inspection

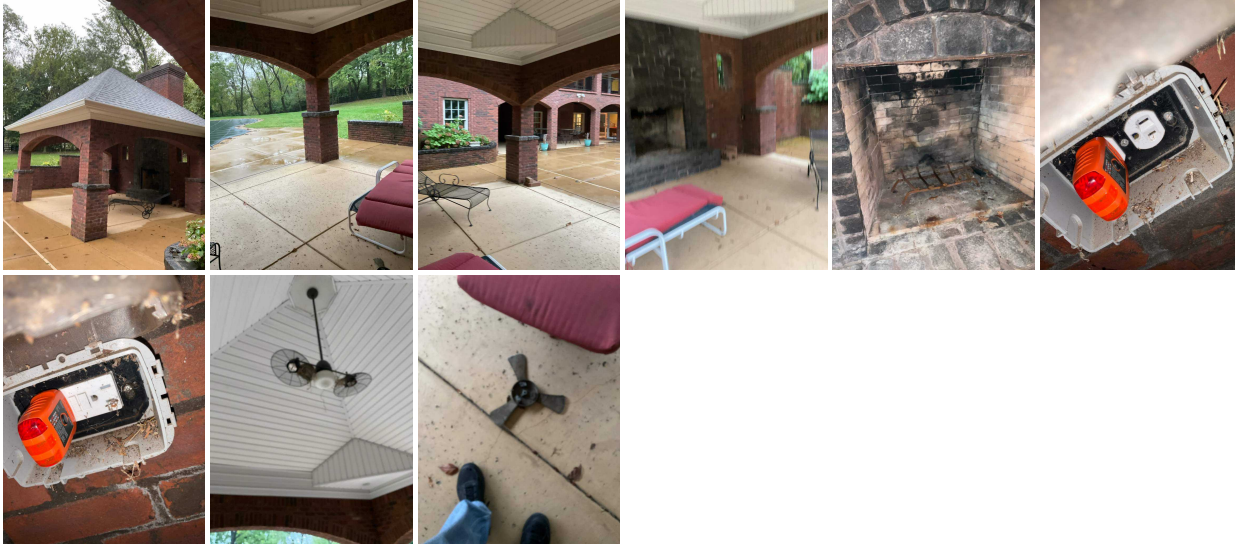
2. Covered patio stand alone structure Brick structure with fireplace. Electric is out, likely cause is bad GFI inside patio. Ceiling fan needs to be replaced.

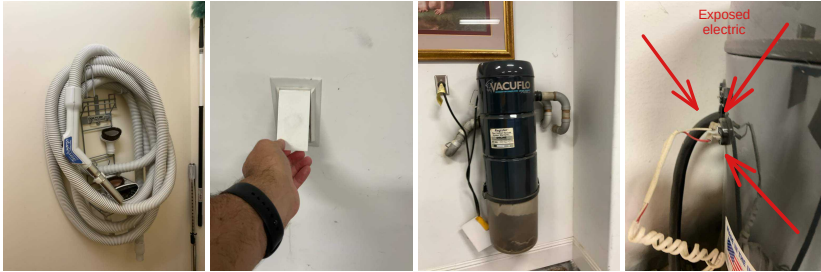
3. Main house Garage Central vacuum This covers both the main and guest house. Noting and writing up exposed electrical wire.

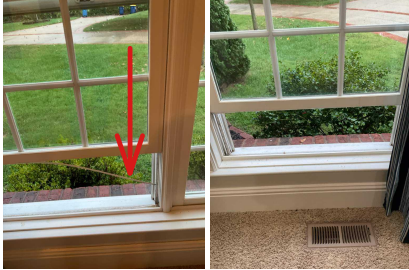
### 6. Garage side Bedroom Windows: Wood

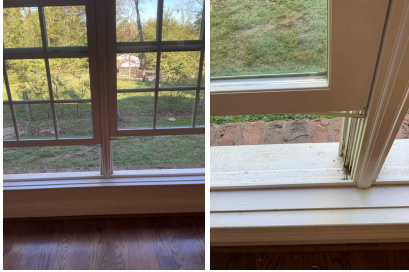
### 7. Guest house Living Space Windows: Wood Glue gasket in place

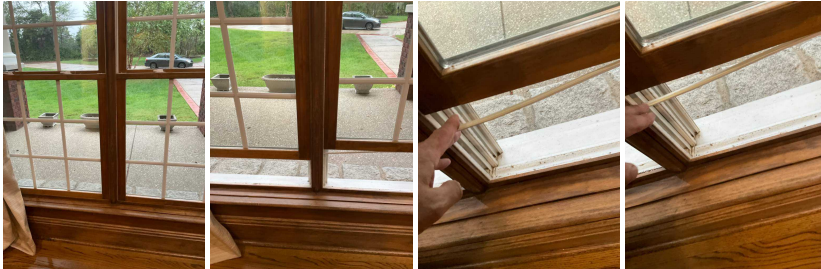
### 8. Library or office Living Space Windows: Wood

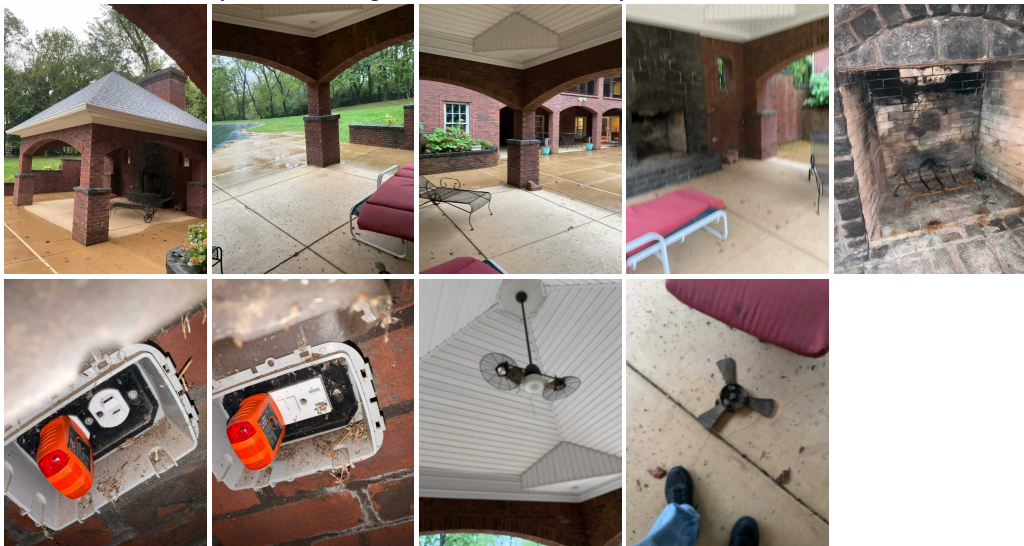
Covered patio stand alone structure Brick structure with fireplace. Electric is out, likely cause is bad GFI inside patio. Ceiling fan needs to be replaced.

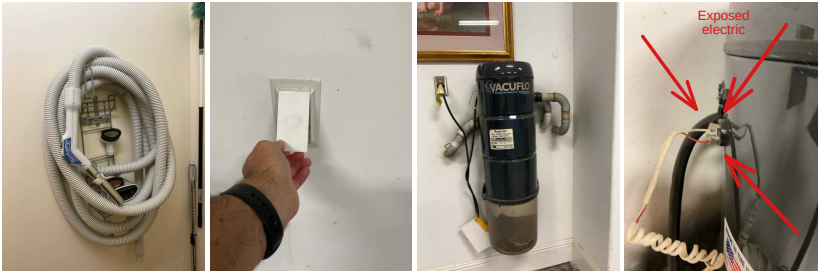
1. Type of Structure: Attached Car Spaces: 3
2. Acceptable Garage Doors: Metal
3. Acceptable Door Operation: Mechanized
4. Acceptable Door Opener: Lift Master
5. Defective Central vacuum This covers both the main and guest house. Noting and writing up exposed electrical wire.

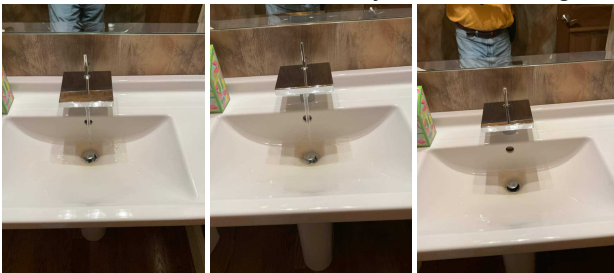
9. Acceptable Faucets/Traps: Showed buyers this facet gets hot when used for hot water.

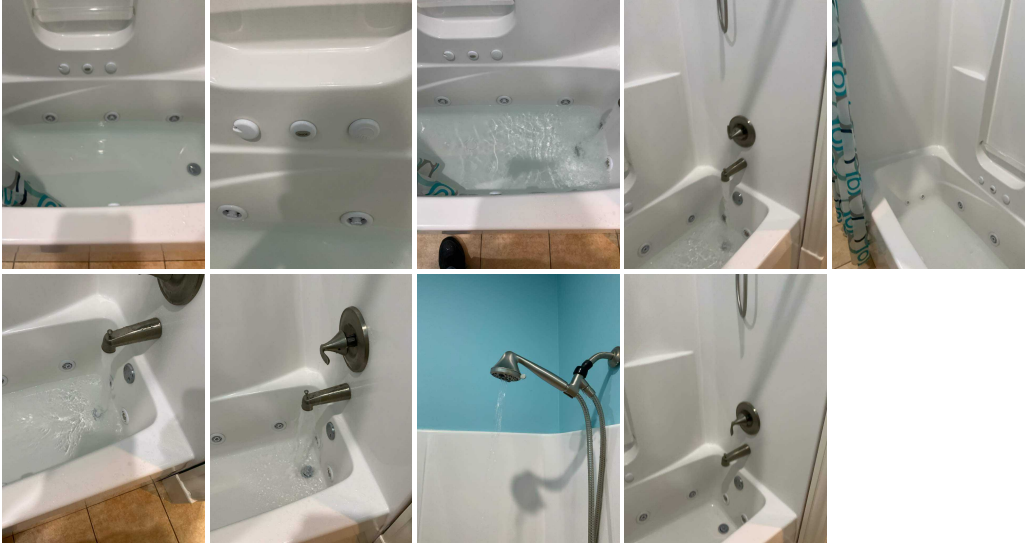
Spa Tub/Surround: Pump inoperable
