Home Inspection Report

8625 Shelbyville Road
Louisville, Kentucky 40222

Inspected by:
Marty Goldsmith Kentucky License 266196
Gold Home Inspection LLC

20:48 March 04, 2022

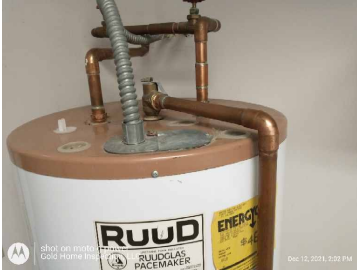
Water Heater Operation: Adequate - Unit was fully functional at time of inspection and per serial number is 33 years old. In practice I commonly see electric hot water heaters lasting a long time. Having the unit inspected by a professional plumber could better determine life and replacement time frame. Upon replacement of unit, I would consider have a drip pan installed.

TPRV and Drain Tube: Copper

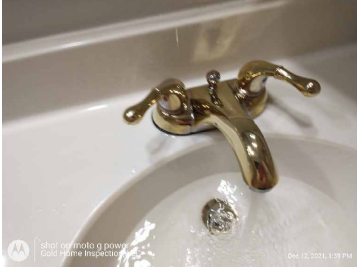
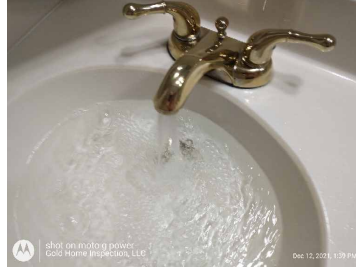
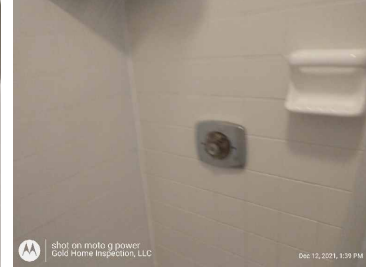
☒☐☐☐☐ Faucets/Traps:

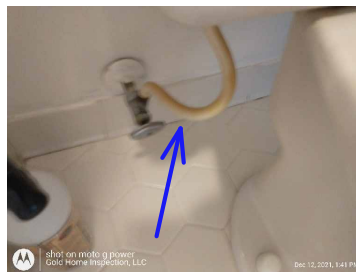
☒☐☐☐☐ Toilets: Having metal braided line reduces the risk of failure and leak to unit below.

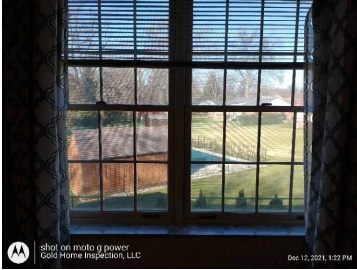
Doors: Hollow wood - Pull out door to closet does not work.
 Windows: Wood - Neither window holds open.

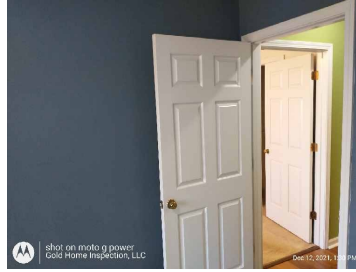
Windows: Wood - Window on right side does not hold open.

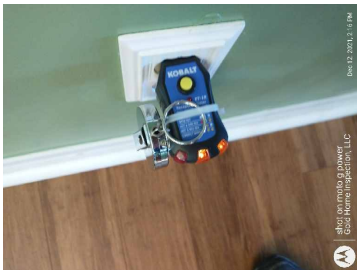
Electrical: 110 VAC - Noting light fixture height.

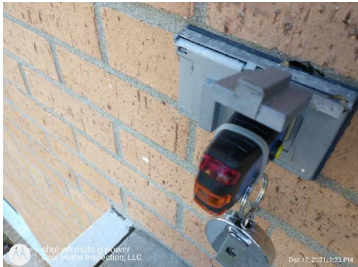
Porch outlet Should be GFI in waterproof enclosure.

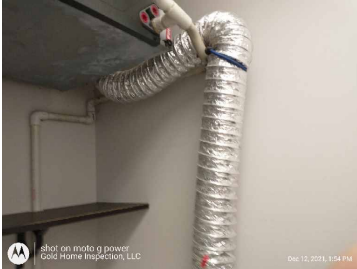
Dryer Vent: Plastic flex

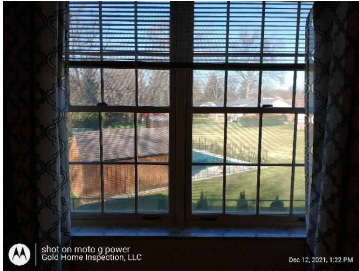
2. Master Bedroom Doors: Hollow wood - Pull out door to closet does not work.
3. Master Bedroom Windows: Wood - Neither window holds open.

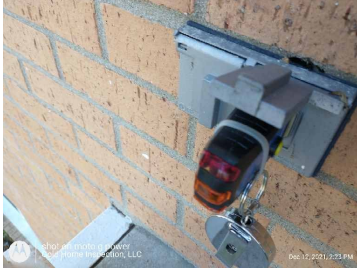
7. Patio Living Space Porch outlet Should be GFI in waterproof enclosure.
