# Home Inspection Report

5807 Medtree Place  
Louisville, KY 40229

Marty Goldsmith Kentucky License 266196  
Gold Home Inspection LLC

20:43 March 04, 2022

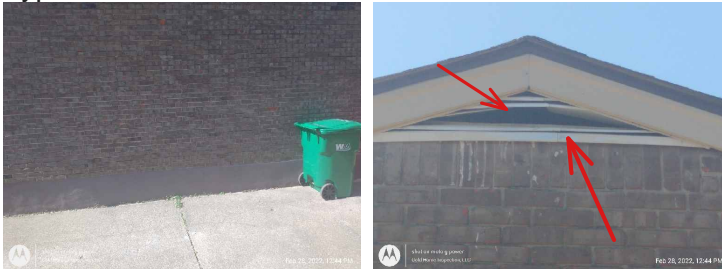
Driveway side Exterior Surface

Type: Brick veneer - Needs to be sealed to prevent animals from entering

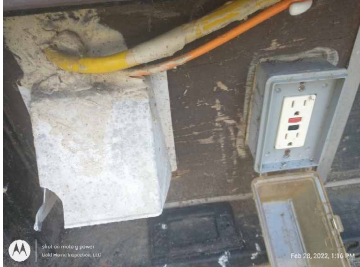
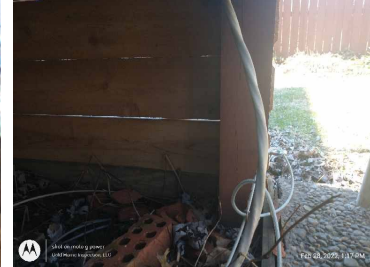
### Exterior Electric Outlets: (continued)

Exterior Electric Outlets: 110 VAC GFCI - Several issues, which should be repaired by licensed electrician.

2. Exterior Electric Outlets: 110 VAC GFCI - Several issues, which should be repaired by licensed electrician.

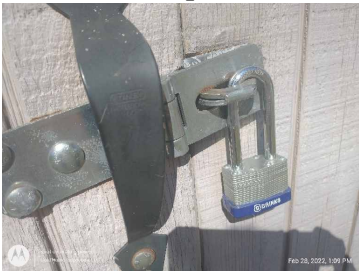
Doors: No key

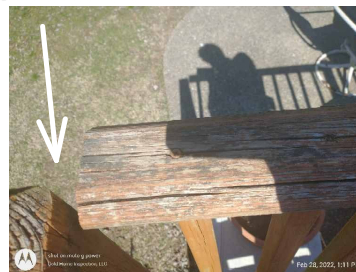
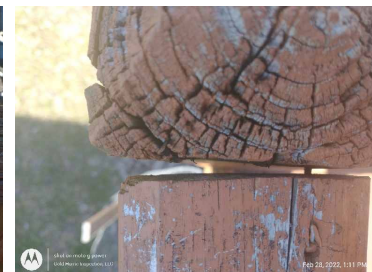
3. Rear Deck Railing: Painted/stained

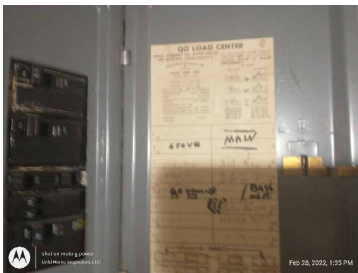
Breaker Index Present

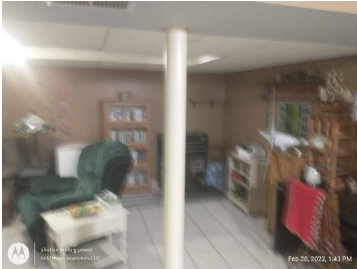
Piers/Posts: Steel posts

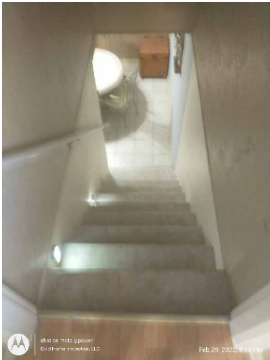
Basement Stairs/Railings: Wood stairs with wood handrails - No door

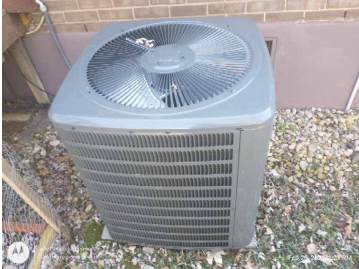
A/C System Operation: Functional - Unit was not tested, outside Temperature above 65 degrees. Unit is less than one year old and likely under warranty. Buyer needs to find out how to get warranty transferred.

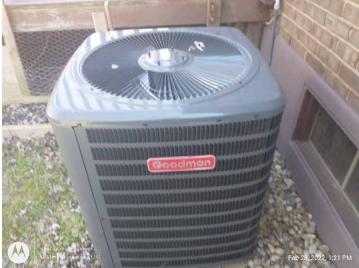
Exterior Unit: Pad mounted

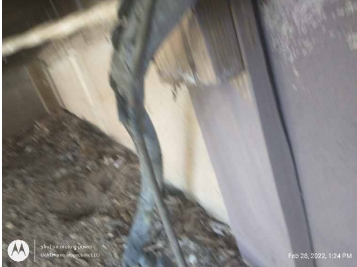
Refrigerant Lines: Suction line and liquid line

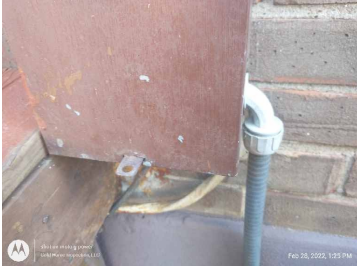
Electrical Disconnect: Breaker disconnect

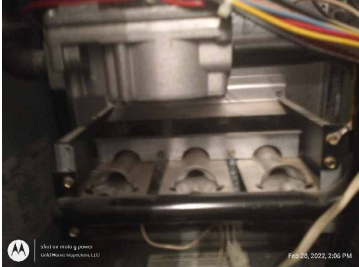
Heat Exchanger: 3 Burner

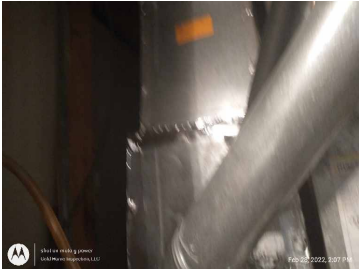
Distribution: Metal duct

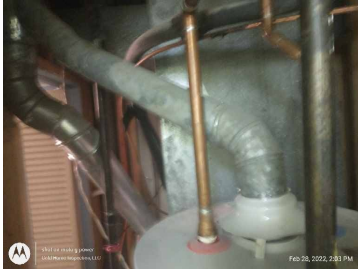
- Flue Pipe: Double wall

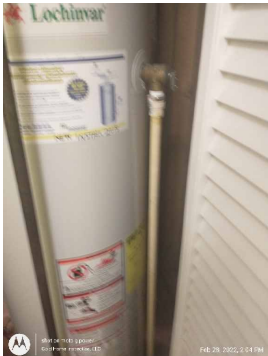
- TPRV and Drain Tube: Plastic

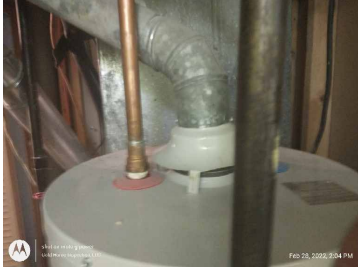
Water Supply lines: Copper

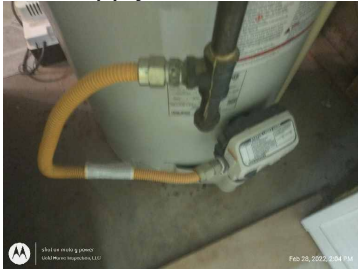
Gas supply line: Flex

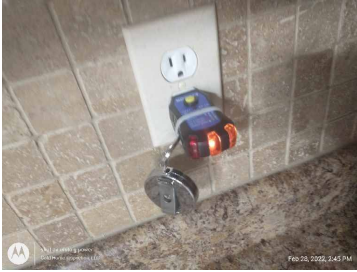
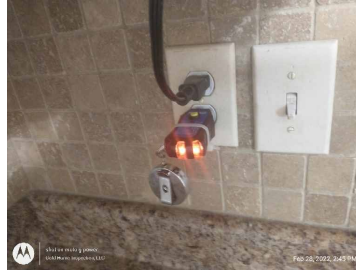
Electrical: 110 VAC - Non-GFCI circuit. Electrical code requires GFI, within 6 feet of water.

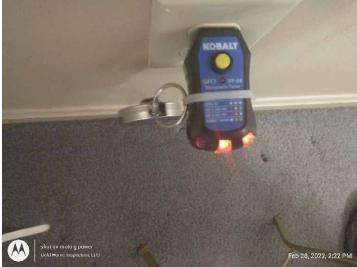
Electrical: 110 VAC

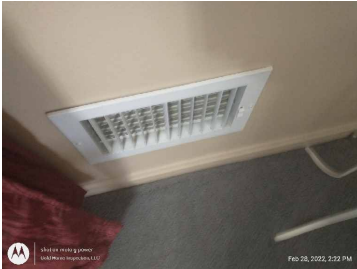
HVAC Source: Heating system register

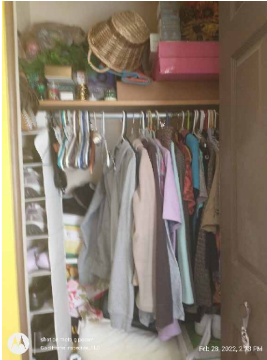
Closet: Single small

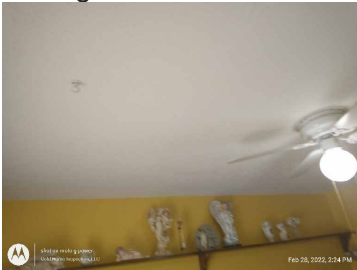
Ceiling: Paint

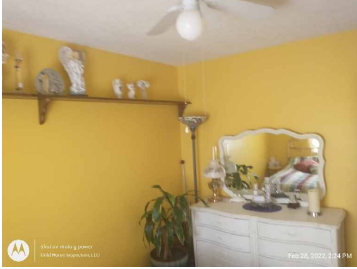
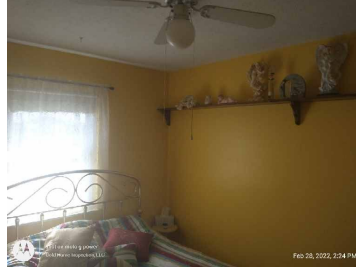
Walls: Paint

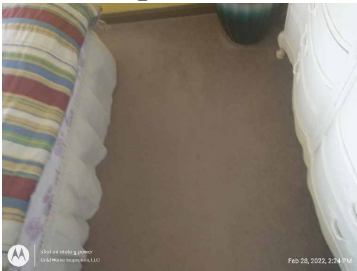
Floor: Carpet

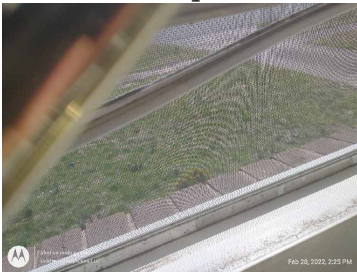
Windows: Vinyl double hung

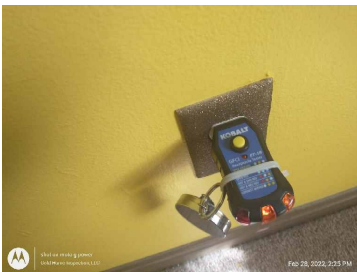
Electrical: 110 VAC

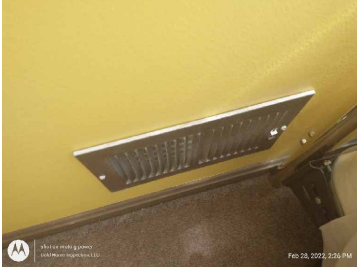
HVAC Source: Heating system register

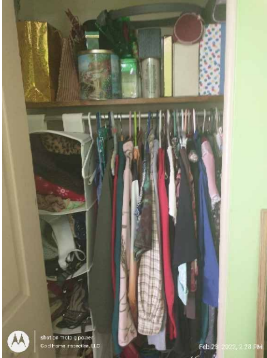
Closet: Single small

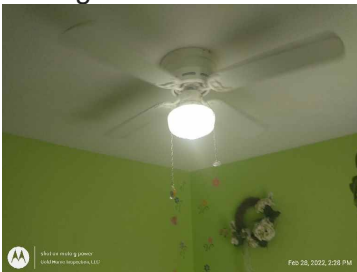
Ceiling: Paint

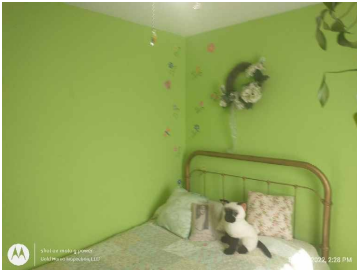
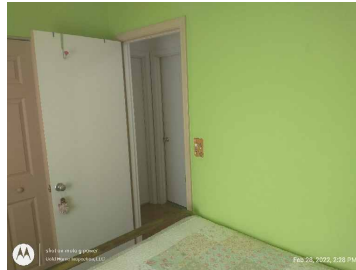
Walls: Paint

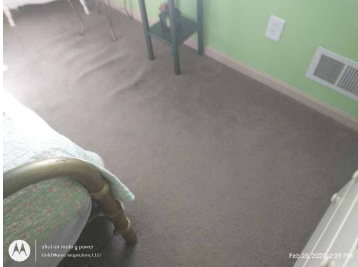
Floor: Carpet

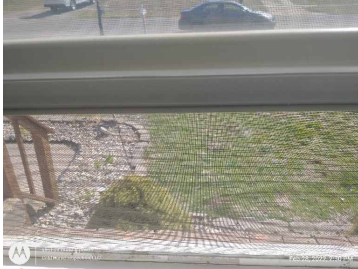
Windows: Vinyl double hung

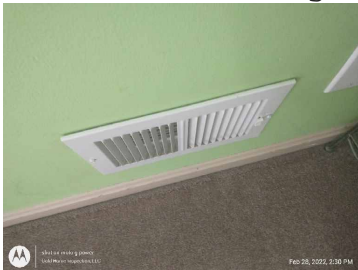
HVAC Source: Heating system register

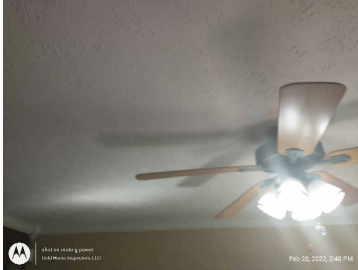
Ceiling: Paint

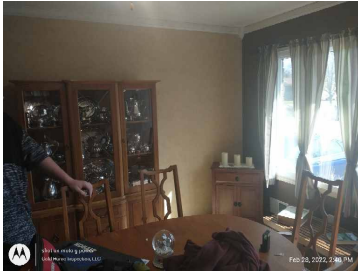
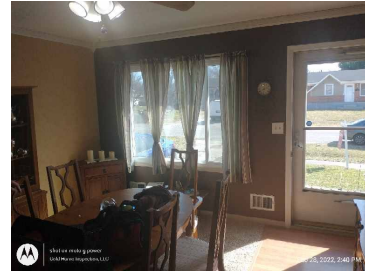
Walls: Paint

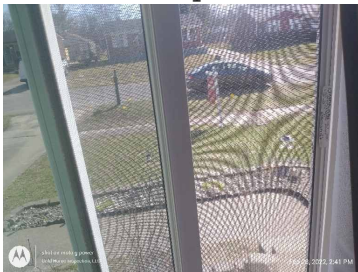
Windows: Vinyl slider

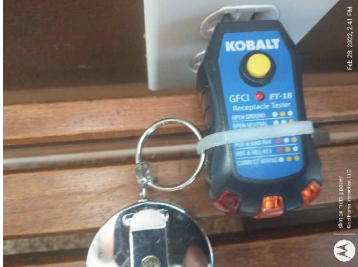
Electrical: 110 VAC

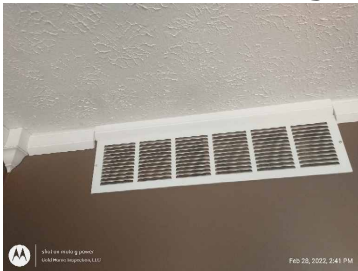
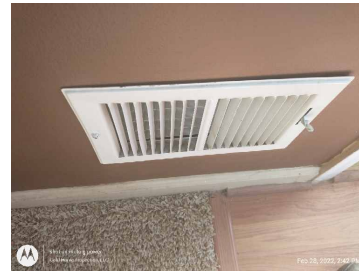
HVAC Source: Heating system register

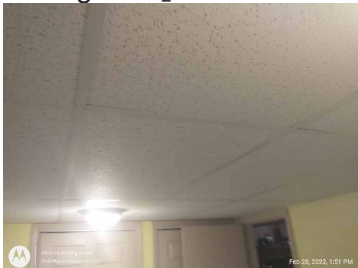
Ceiling: Suspended ceiling

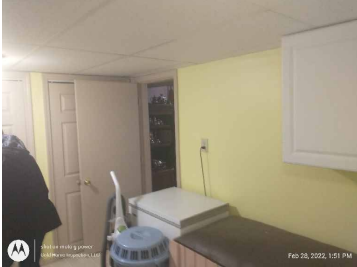
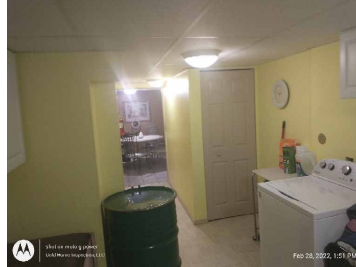
☒☐☐☐☐ Walls: Paint

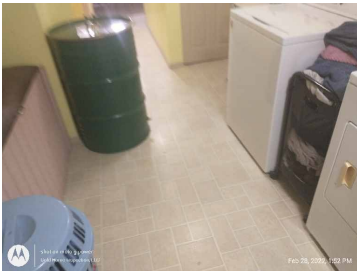
☒☐☐☐☐ Floor: Linoleum

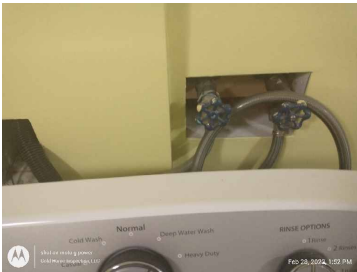
☒☐☐☐☐ Washer Hose Bib: Gate valves

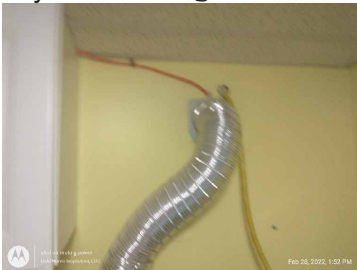
☒☐☐☐☐ Dryer Vent: Rigid metal

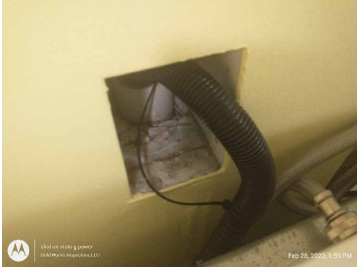
Washer Drain: Wall mounted drain

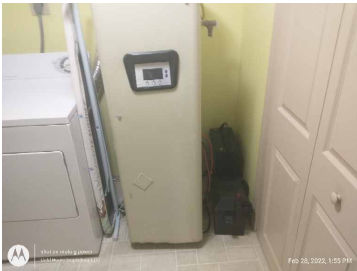
Laundry Room/Area

Solar hot water

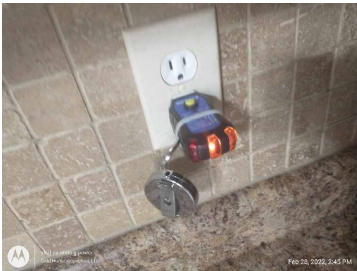
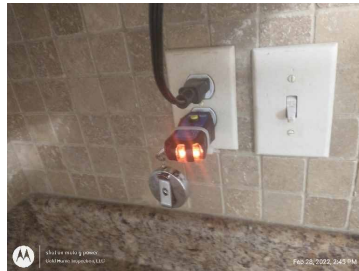
### Kitchen

10. 1st Floor Kitchen Electrical: 110 VAC - Non-GFCI circuit. Electrical code requires GFI, within 6 feet of water.
