# Home Inspection Report

Marty Goldsmith Kentucky License 266196  
Gold Home Inspection LLC

20:45 March 04, 2022

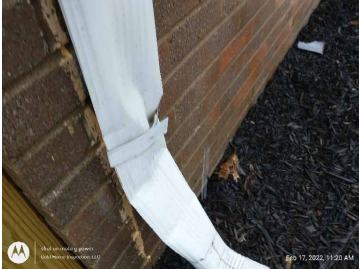
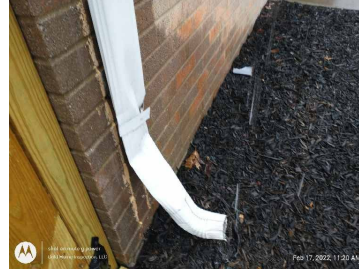
Gutters: Aluminum - Front corner at driveway gutter needs to be properly mounted to structure.

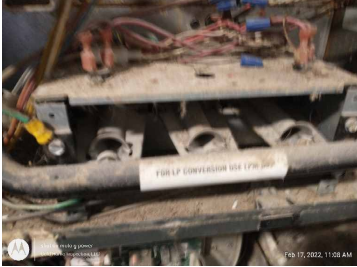
Heating System Operation: Adequate - Unit was made in 2011 and working at time of inspection. No place for filter and the unit is very dirty. Recommend proper mounts be installed for filter and unit be cleaned. Property owner needs to educate future renters of need to change filters. I recommend they are changed monthly and on the day LGE bills arrive. Furnace needs to be cleaned and serviced.

Heat Exchanger: 3 Burner

Interior is top notch. I would recommend that the heater be serviced and filter be installed and regularly changed. Central air unit, was not tested and is at the end of its life and should be budgeted for replacement. Roof needs to have drip edged installed. Couple of windows did not hold open.

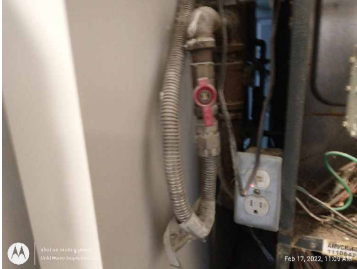
Blower Fan/Filter: Direct drive with reusable filter  
     Gas supply line: Flex

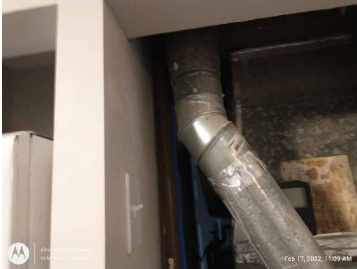
Flue Pipe: Double wall

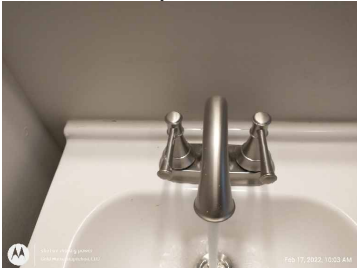
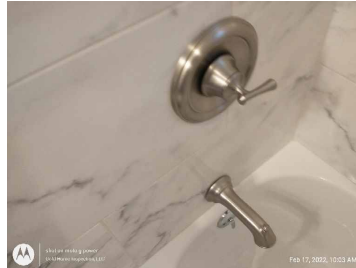
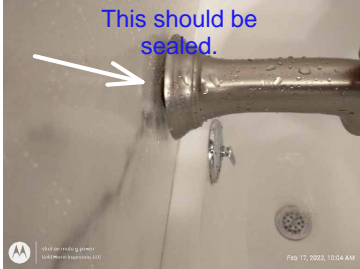
Faucets/Traps: Bath tub spicket needs to be tighten and sealed.

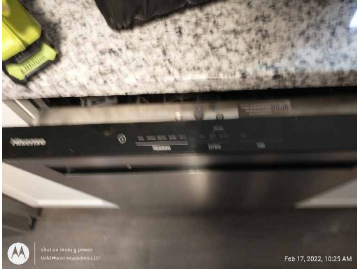
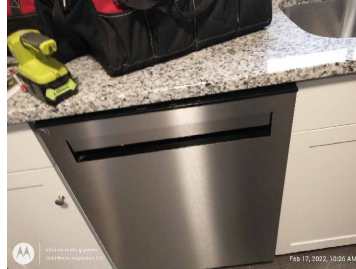
Dishwasher: Not mounted, unit would not start. Water is likely shut off and inspector did not want to turn it on.

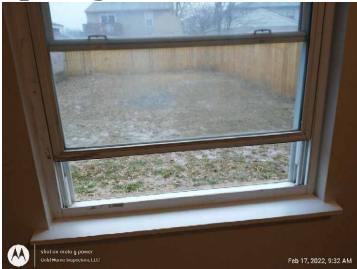
Windows: Vinyl double hung - Window does not shut good. Likely support springs

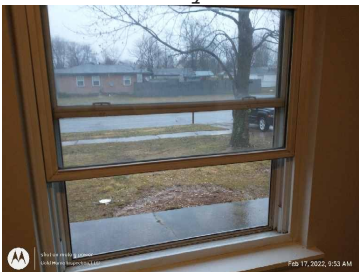
Windows: Vinyl double hung - Window does not close

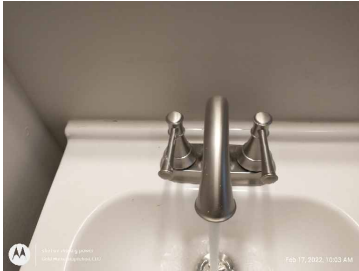
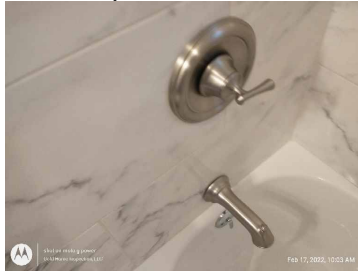
1. 1st floor main Bathroom Faucets/Traps: Bath tub spicket needs to be tighten and sealed.

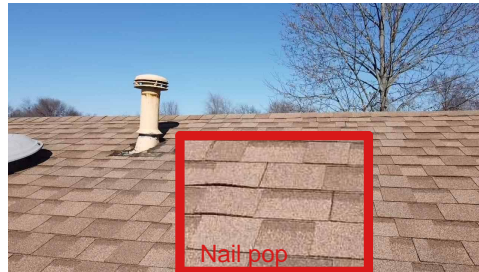
1. Main Roof Surface Material: Asphalt shingle - Roof has considerable life remaining. Two issues, no drip edges installed. Drip edge support shingles at the edge of the roof where the meet gutters. Shingles along the perimeter will fail if they do not have this. Vents, house has a power vent, which is electrical powered with a thermostat, testing these units is very difficult and you have no way to know if they work. Box vents are a simple solution that provide good air flow and limited service.

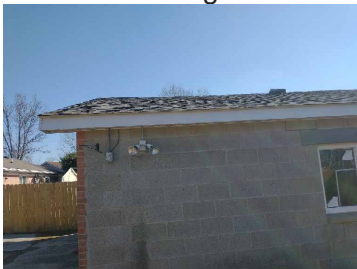
- 3. Detached Garage Gutters: None

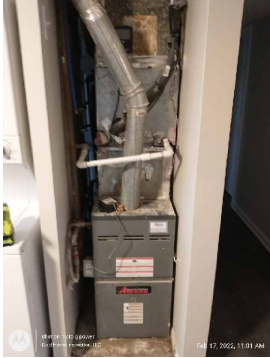
6. Main Heating System Heating System Operation: Adequate - Unit was made in 2011 and working at time of inspection. No place for filter and the unit is very dirty. Recommend proper mounts be installed for filter and unit be cleaned. Property owner needs to educate future renters of need to change filters. I recommend they are changed monthly and on the day LGE bills arrive. Furnace needs to be cleaned and serviced.

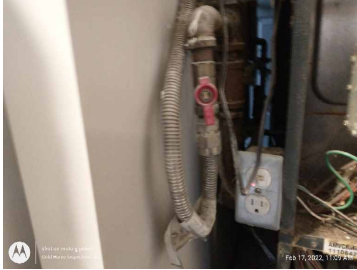
7. Main Heating System Gas supply line: Flex

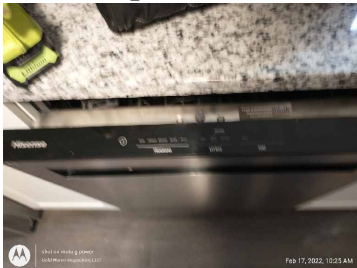
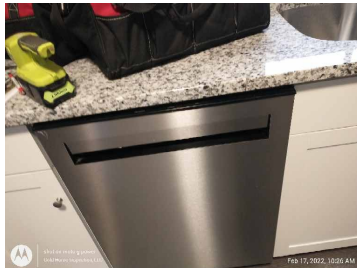
9. 1st Floor Kitchen Dishwasher: Not mounted, unit would not start. Water is likely shut off and inspector did not want to turn it on.

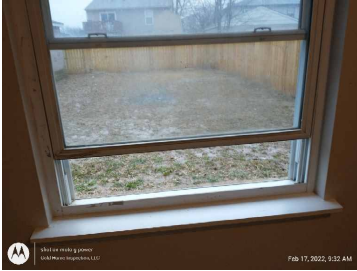
10. Rear Bedroom Windows: Vinyl double hung - Window does not shut good. Likely support springs

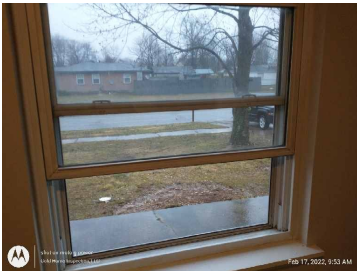
11. Front center Bedroom Windows: Vinyl double hung - Window does not close
