Home Inspection Report

4006 Dover Court
Louisville, Kentucky 40216

Marty Goldsmith Kentucky License 266196
Gold Home Inspection LLC

20:52 March 04, 2022

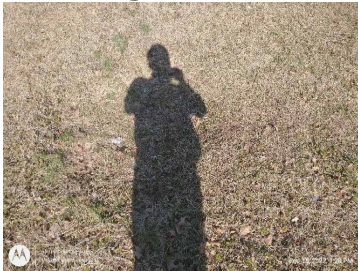
Grading: Flat
Yard Large hole - Safety issue and should be filled in.

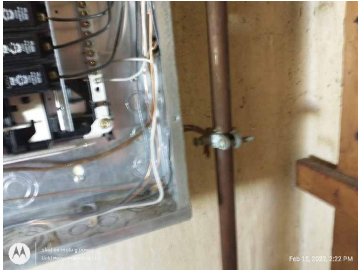
- Service: Copper
- 120 VAC Branch Circuits: Copper
- 240 VAC Branch Circuits: Copper and aluminum
- Aluminum Wiring: Not present
- Ground: Plumbing and rod in ground

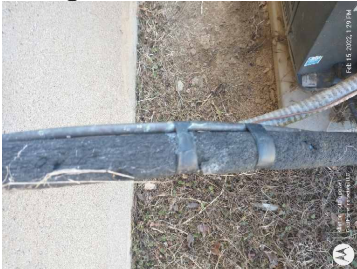
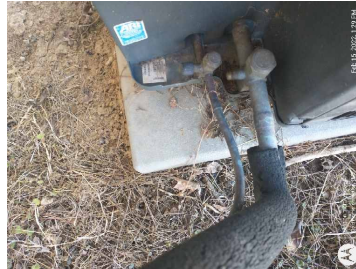
A/C System Operation: Outdoor range was below the normal operating Temperature and not tested. Based upon 15 year age and brand this unit in near the end of its life and homeowner should budget for replacement. Defective score given for age.

Visible Coil: Aluminum
 Refrigerant Lines: Suction line and liquid line

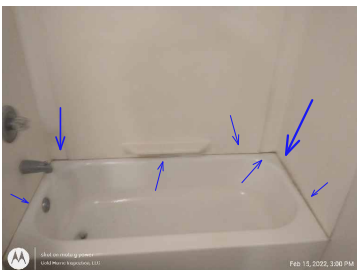
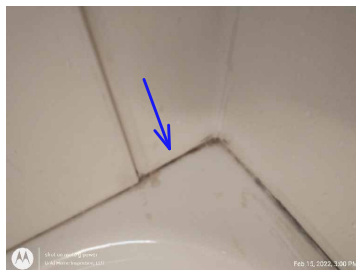
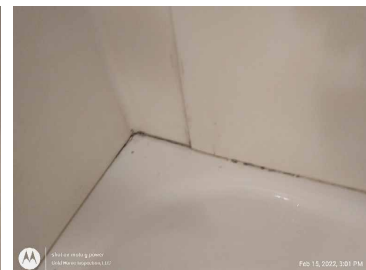
Tub/Surround: Porcelain tub and fiberglass surround - This needs to be cleaned with mold remover

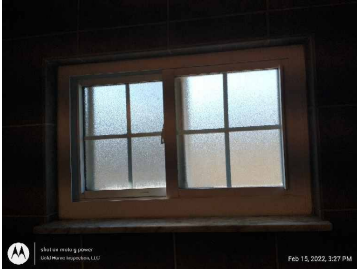
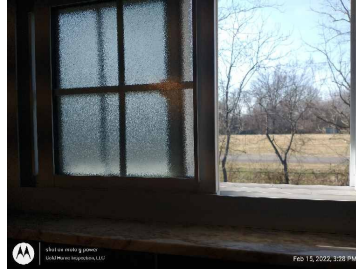
Windows: Vinyl double hung

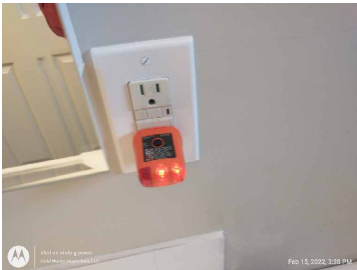
Electrical: 110 VAC GFCI

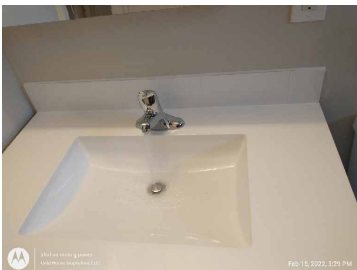
Counter/Cabinet: Wood

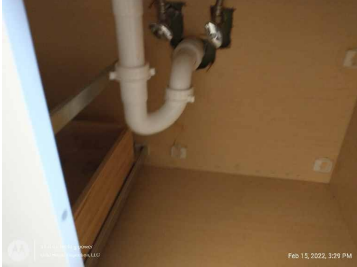
☒☐☐☐☐ Sink/Basin: Molded single bowl

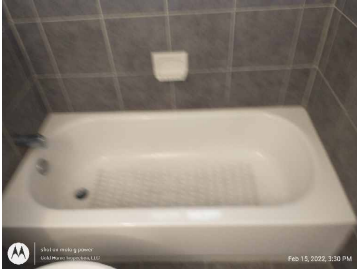
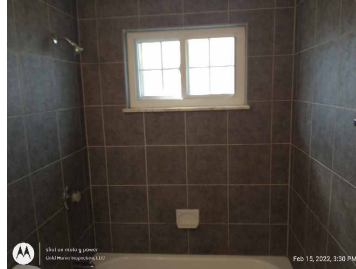
☒☐☐☐☐ Tub/Surround: Porcelain tub and ceramic tile surround

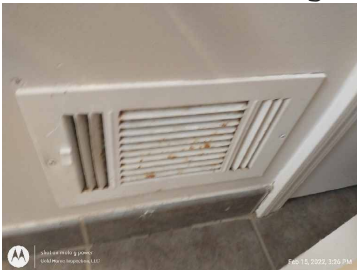
☒☐☐☐☐ HVAC Source: Heating system register

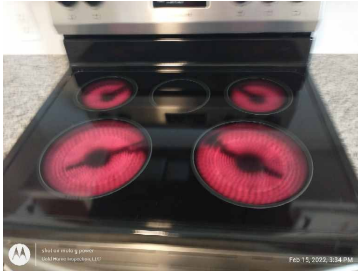
Stove: Frigidaire

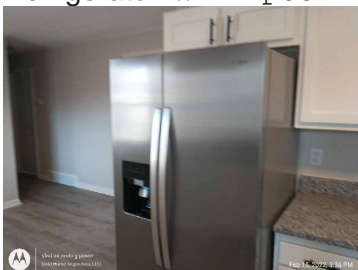
Refrigerator: Whirlpool

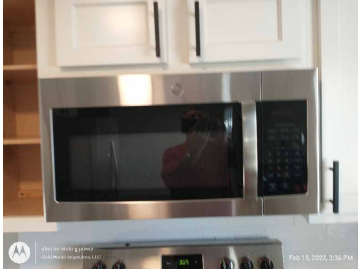
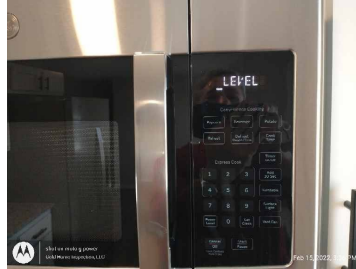
☒ ☐ ☐ ☐ ☐ Microwave: GE

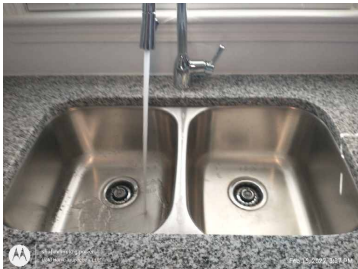
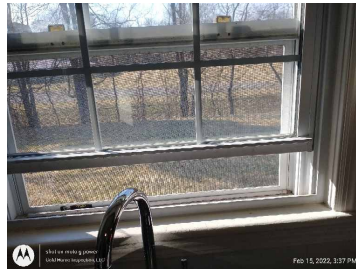
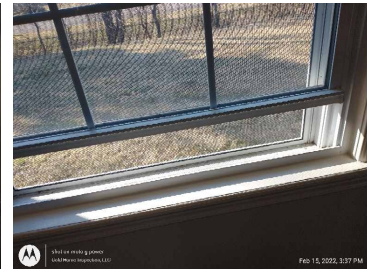
☒ ☐ ☐ ☐ ☐ Sink: Stainless Steel

Water leaks are noted in multiple pipes below the sink and require plumbing repairs.

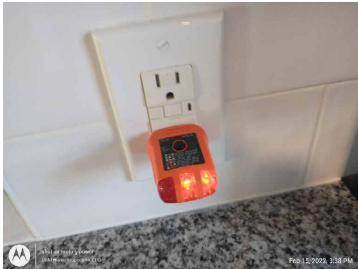
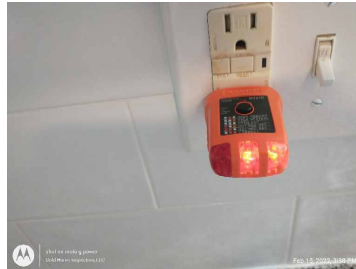
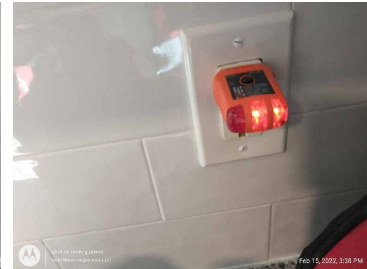
☒ ☐ ☐ ☐ ☐ Electrical: 110 VAC

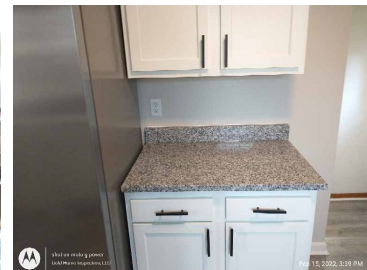
☒ ☐ ☐ ☐ ☐ Counter Tops: Granite

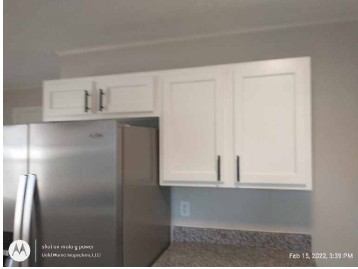
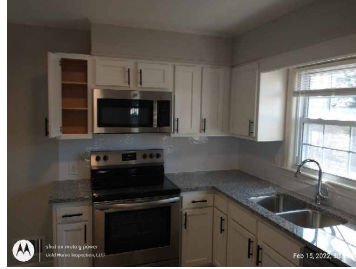
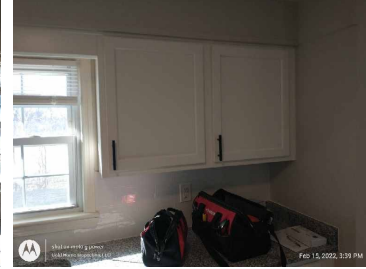
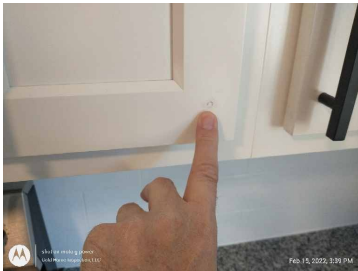
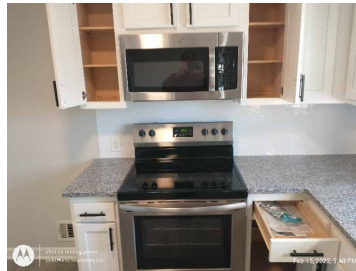
Cabinets: Wood

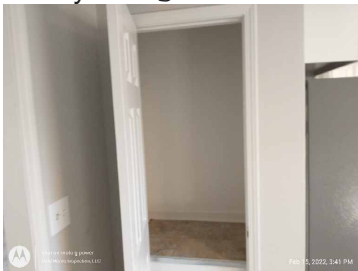
Pantry: Single small

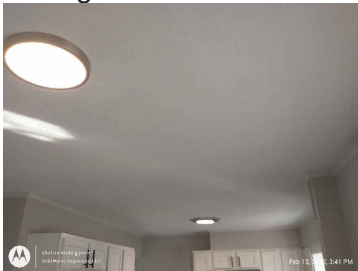
Ceiling: Paint

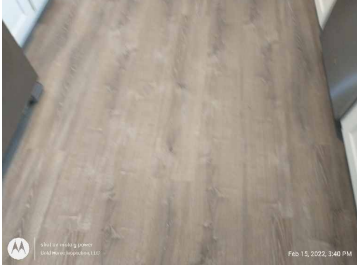
Floor: Laminate

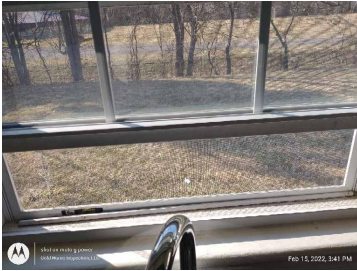
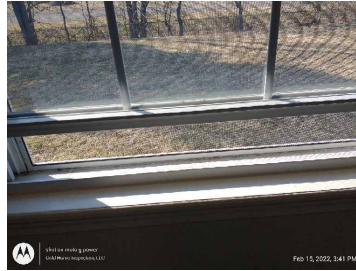
Windows: Vinyl double hung

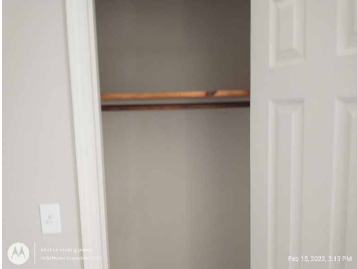
Master Bedroom

Closet: Single

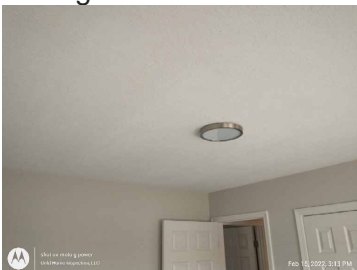
Ceiling: Paint

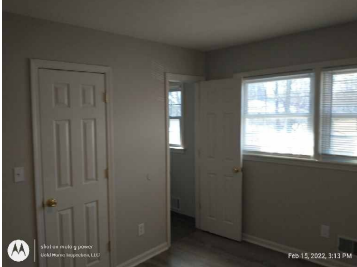
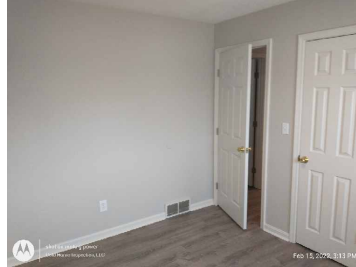
Walls: Paint

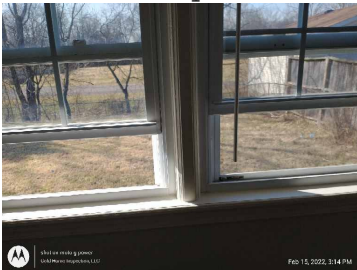
Windows: Vinyl double hung

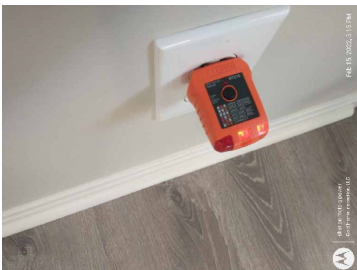
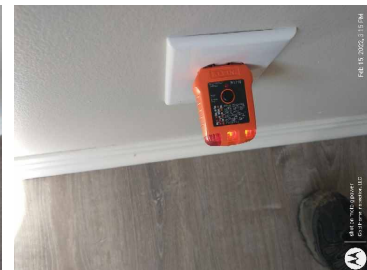
Electrical: 110 VAC

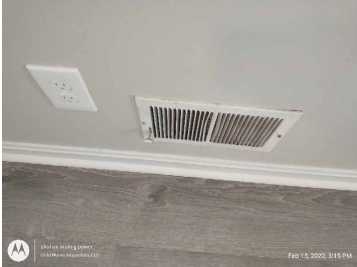
HVAC Source: Heating system register

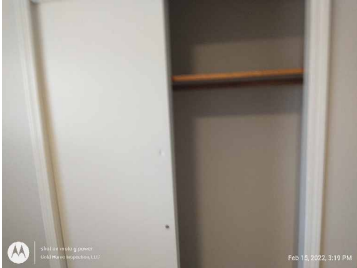
Front corner Bedroom

Closet: Single small

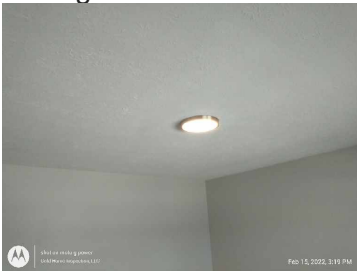
Ceiling: Paint

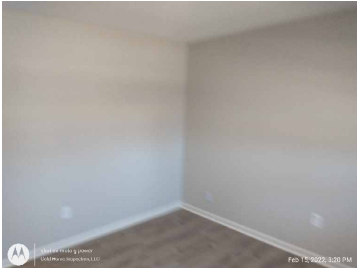
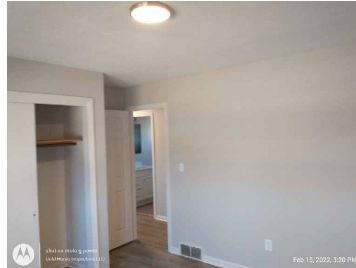
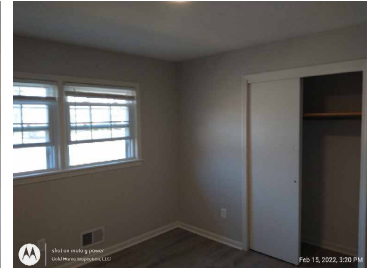
Walls: Paint

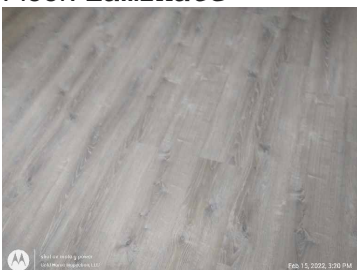
Floor: Laminate

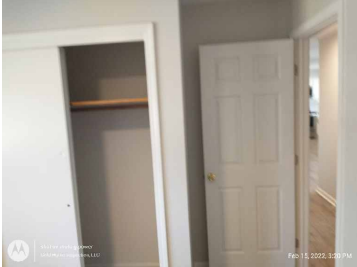
Doors: Hollow wood

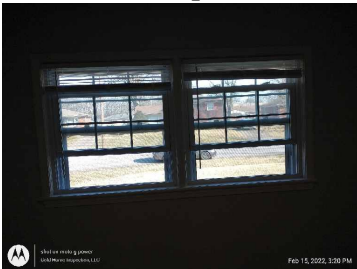
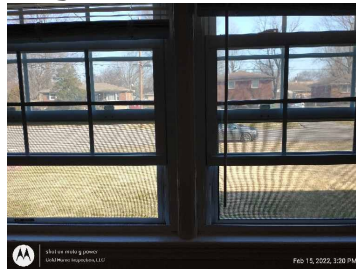
Windows: Vinyl double hung

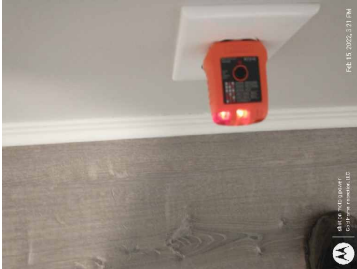
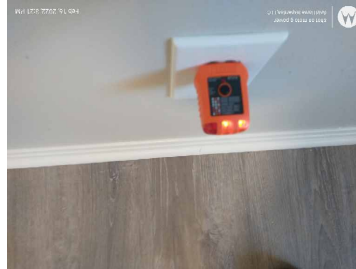
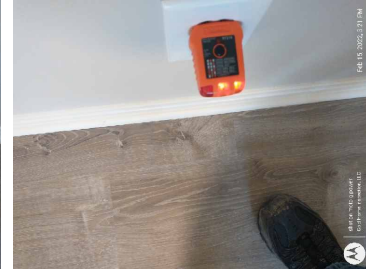
Electrical: 110 VAC

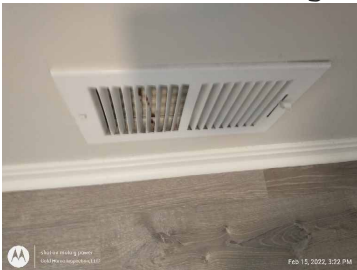
HVAC Source: Heating system register

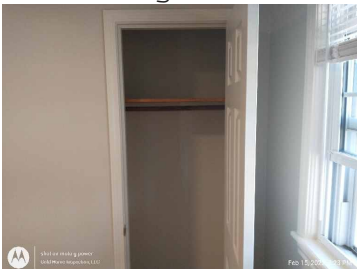
Front center Bedroom

Closet: Single small

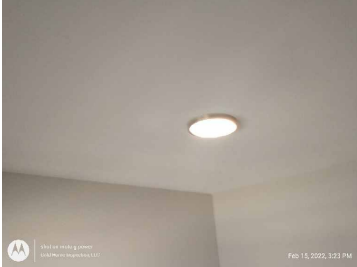
Ceiling: Paint

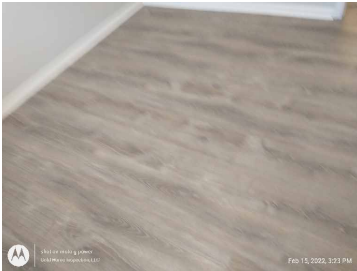
Floor: Laminate

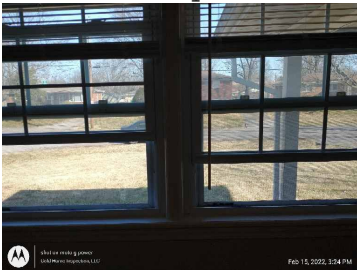
Windows: Vinyl double hung

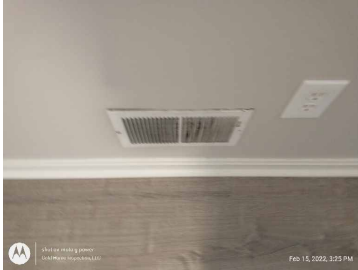
- HVAC Source: Heating system register

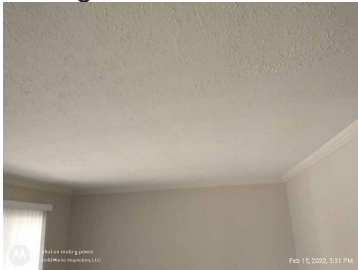
Living Room Living Space

- Ceiling: Paint

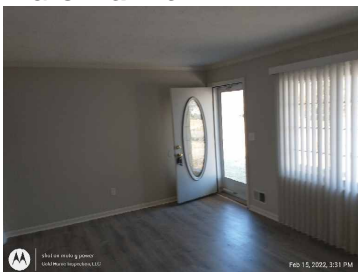
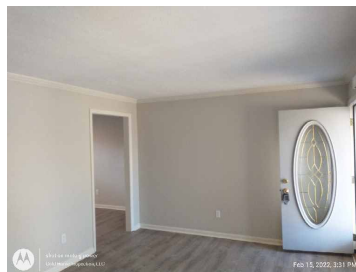
- Walls: Paint

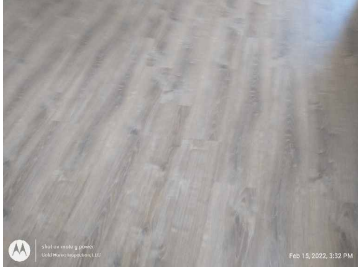
Floor: Laminate

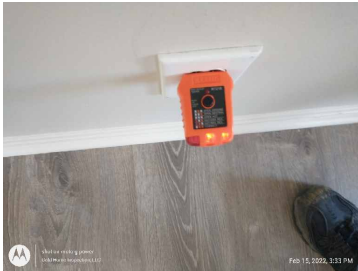
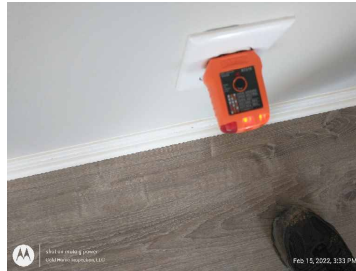
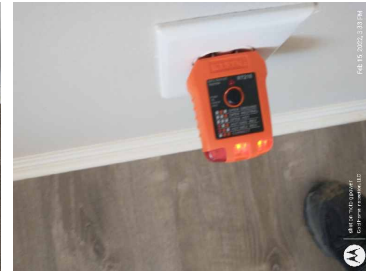
Electrical: 110 VAC

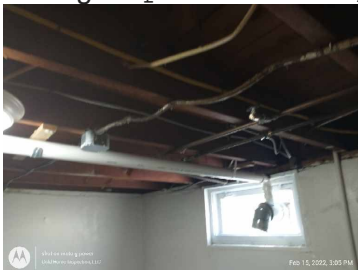
Ceiling: Exposed framing

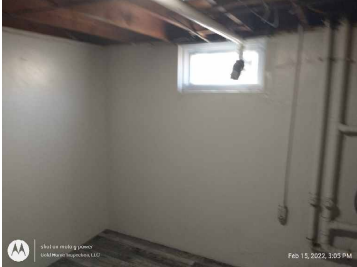
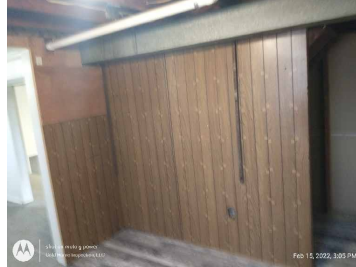
☒☐☐☐☐ Walls: Paint

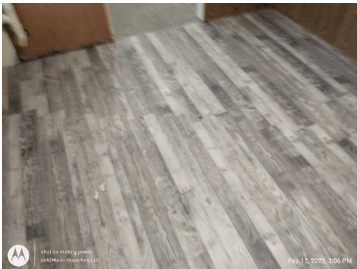
☒☐☐☐☐ Floor: Poured

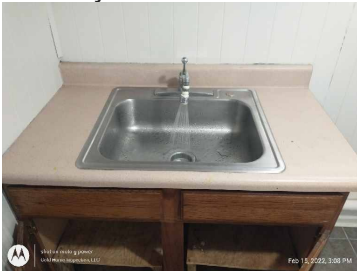
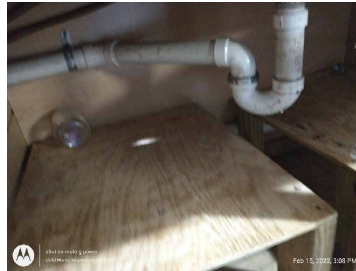
☒☐☐☐☐ Laundry Tub: Cabinet

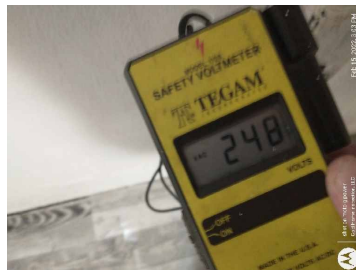
☒☐☐☐☐ Dryer electric Line:

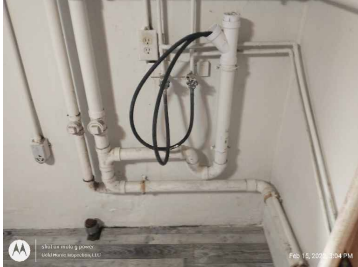
Washer Drain: Wall mounted drain

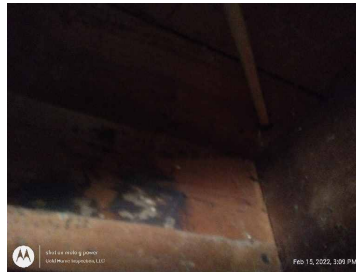
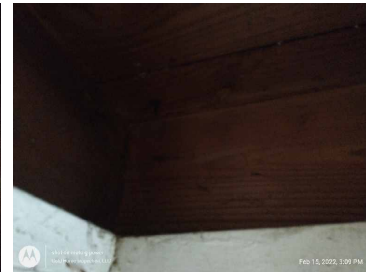
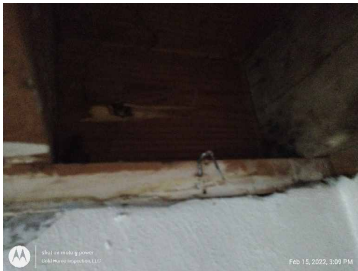
No evidence of WDO present.

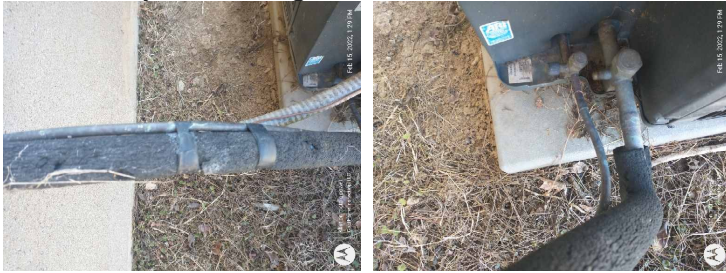
1. Main AC System Refrigerant Lines: Suction line and liquid line

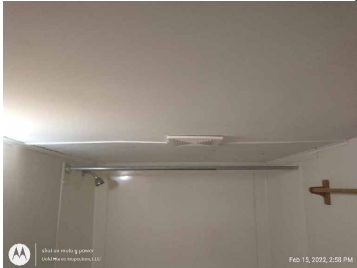
9. Basement Bathroom Ceiling: Six foot ceiling height

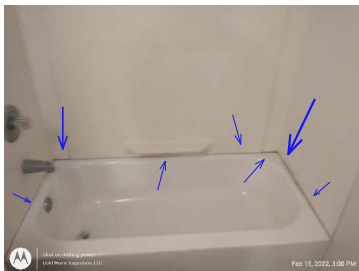
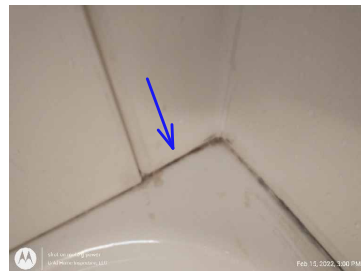
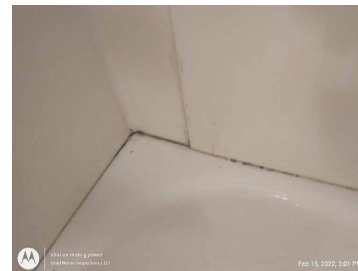
10. Basement Bathroom Tub/Surround: Porcelain tub and fiberglass surround - This needs to be cleaned with mold remover
