# Home Inspection Report

14302 Lake Forest Drive  
Louisville, KY 40245

Marty Goldsmith Kentucky License 266196  
Gold Home Inspection LLC

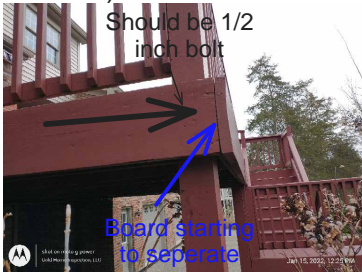
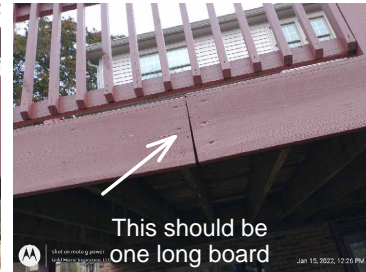
Deck Boards: Deck problems - Missing or wrong size deck hangers. Missing lag bolts, these 1/2 bolts are designed to hold a considerable weight, using small nails or bolts will lead to a failure. Missing ledger bolts and washers, repair using a board to try and support ledger board is not to code and will not work. Insured carpenter or handyman should repair the deck. Complete repairs will prolong the life of the deck. Decks are the number one source of home injuries.

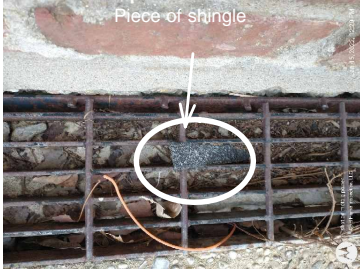
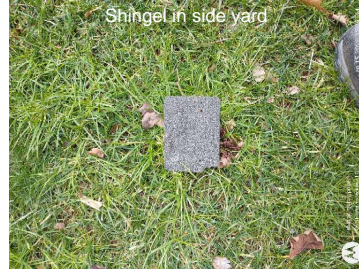
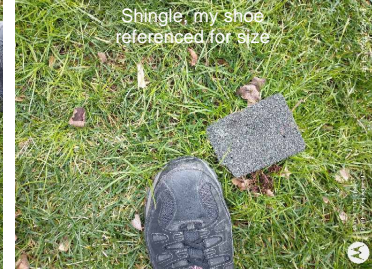
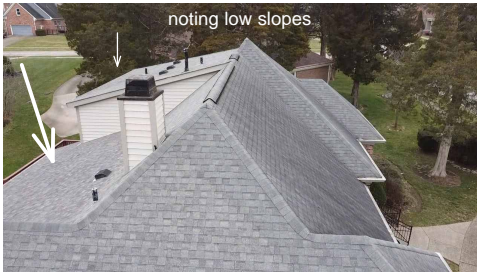
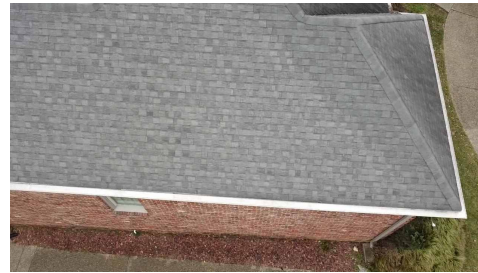
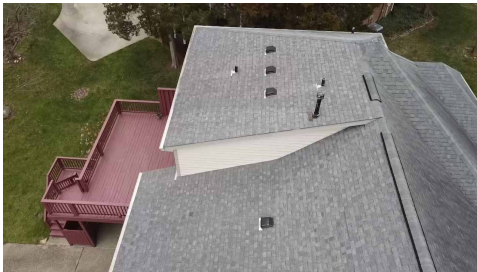
Material: (continued)

Material: ROOF - Very difficult to estimate the age of the roof. We have pictures of shingles coming up on the front slope, above the living room windows, about five feet from the gutter. We have pictures of a small leak in the center bedroom. The ceiling in this room is painted white, while other second floor ceilings are painted yellow and this makes finding leaks very difficult. These issues should be repaired by an insured roofing contractor. We also have missing glandular and missing shingles, which we have pictures of, the roof should have had installed rolled roofing in the dead valley and over the second floor bedrooms. The roof is aging, has incorrect products installed and following recommendations from a roofing contractor, would be in the best interest of the purchaser.

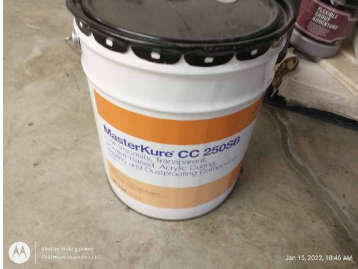
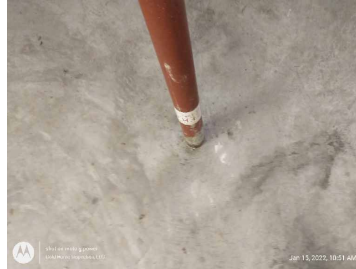
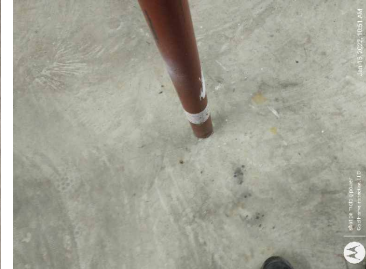
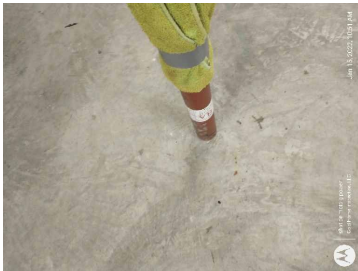
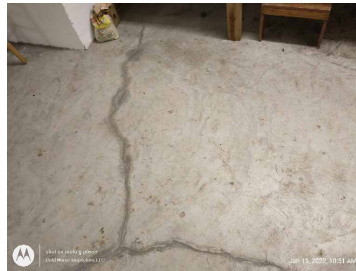
Floor/Foundation: Floor has cracking and has been repaired. Homeowner should monitor this situation.

1. Attached Garage Floor/Foundation: Floor has cracking and has been repaired. Homeowner should monitor this situation.

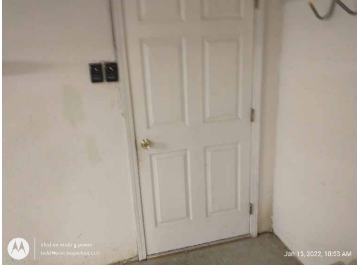
Basement door Hollow wood - This should be fire rated door.

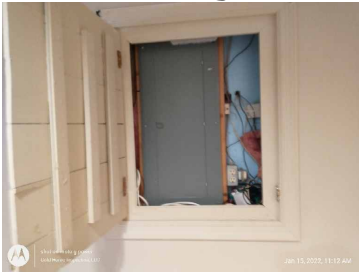
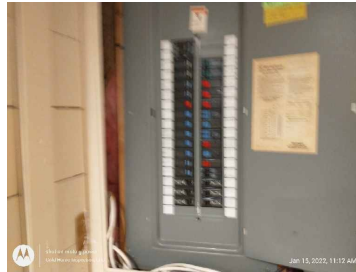
Manufacturer: Westinghouse - Frame around the panel prevent the inspector from removing the cover.

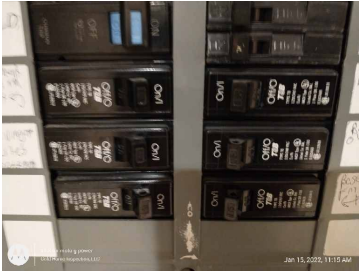
Breakers: Copper - Noting that T and B B breakers have been added.

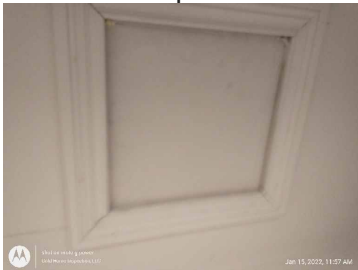
Unable to Inspect: Entrance in corner closet is 12 x 12

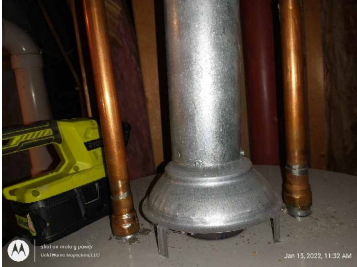
Water Supply lines: Copper

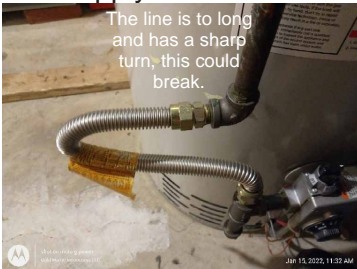
Gas supply line: Flex

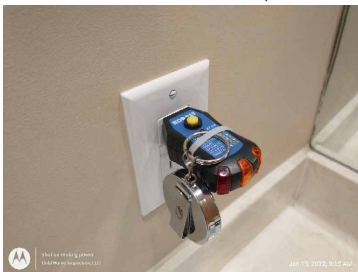
☒☐☐☐☐ Electrical: 110 VAC/220 VAC - Wired together

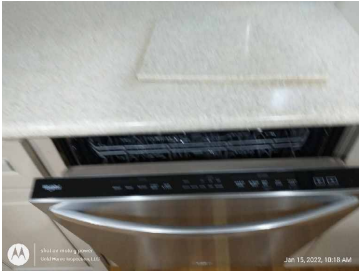
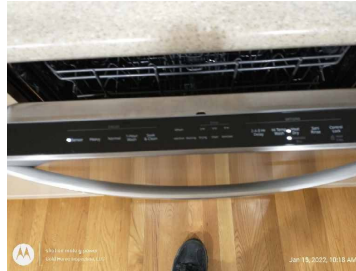
Dishwasher: Whirlpool - Not trusted, no water. Unit powered up.

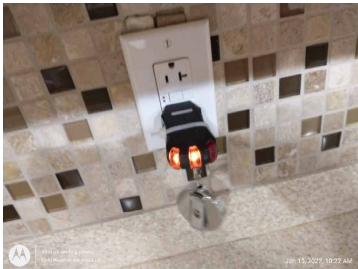
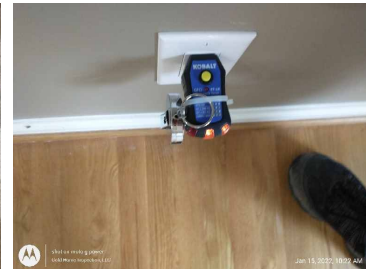
Electrical: 110 VAC GFCI

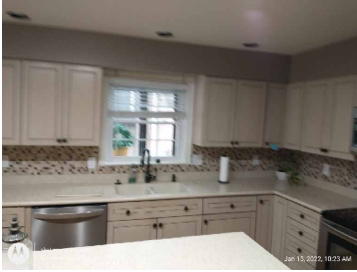
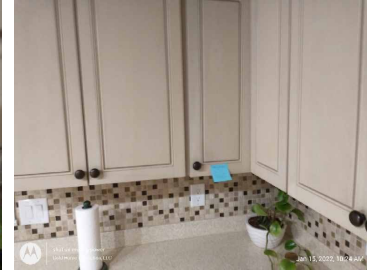
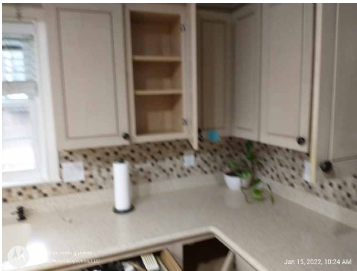
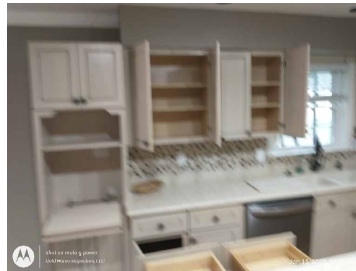
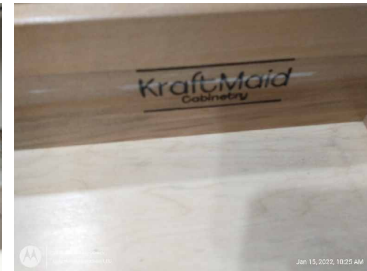
Cabinets: Wood - Lazy susan on the upper cabinets needs a hinge remounted. This is a handyman type of work.

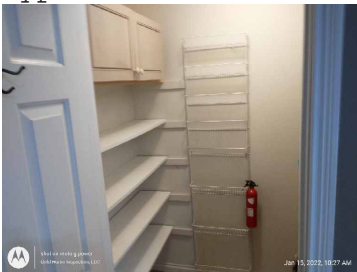
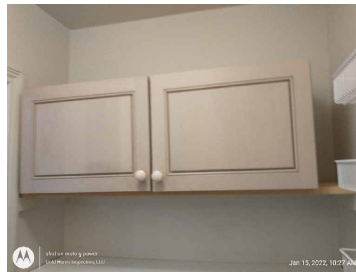
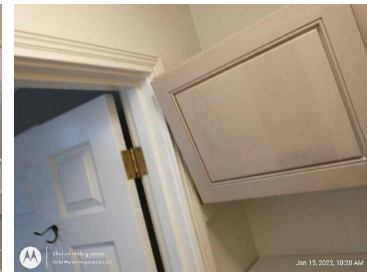
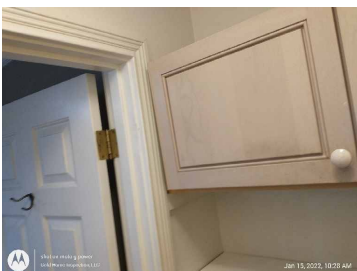
Pantry: Large - Cabinet is not mounted and needs to be secured. Handyman type issue.

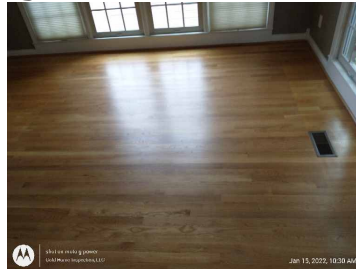
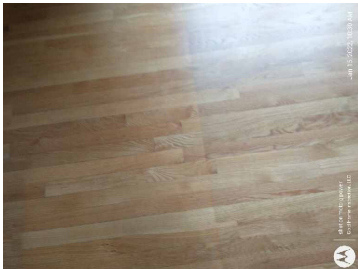
☒☐☐☐☐ Floor: Hardwood - Noting discoloration marks.

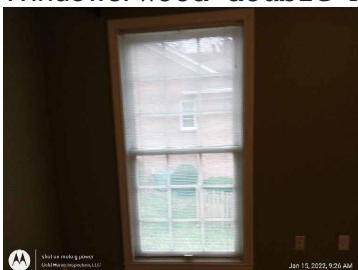
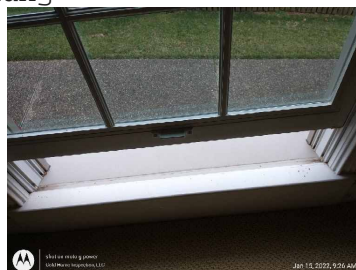
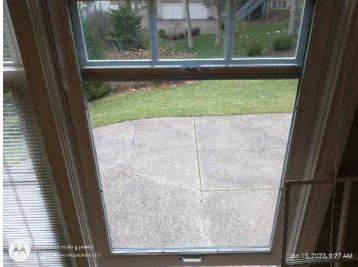
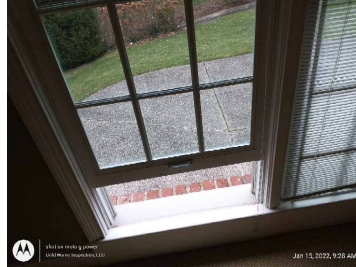
Windows: Wood double hung

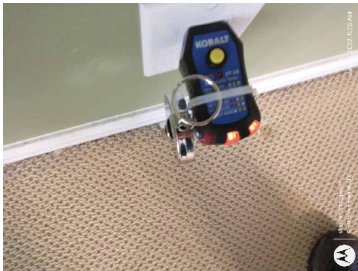
Electrical: 110 VAC

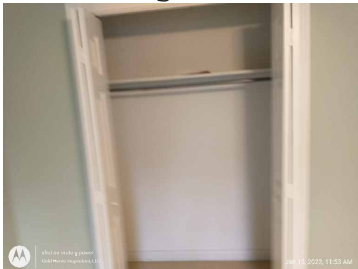
Second floor corner Bedroom

Closet: Large

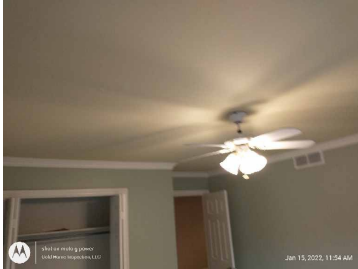
Ceiling: Paint

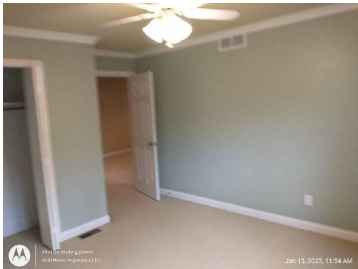
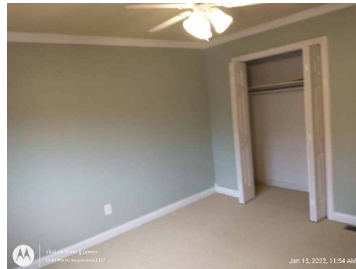
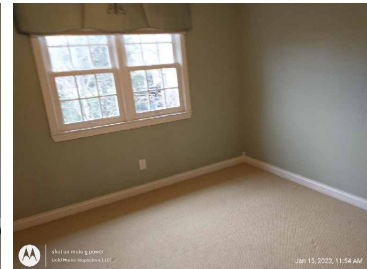
Walls: Paint

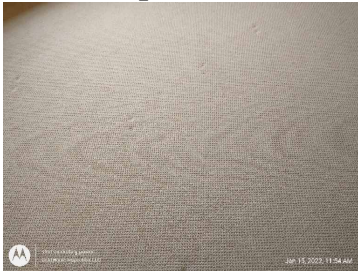
Floor: Carpet

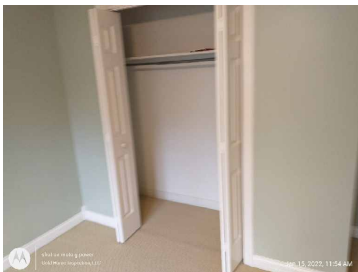
Doors: Hollow wood

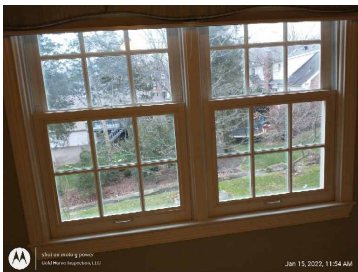
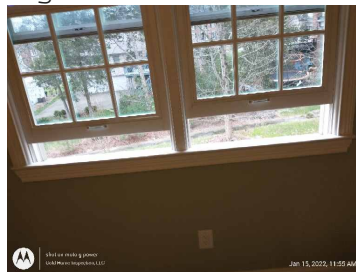
Windows: Wood double hung

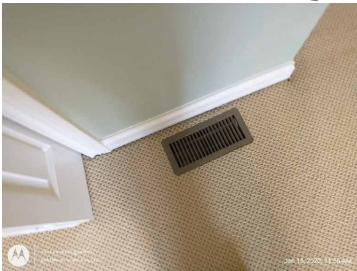
HVAC Source: Heating system register

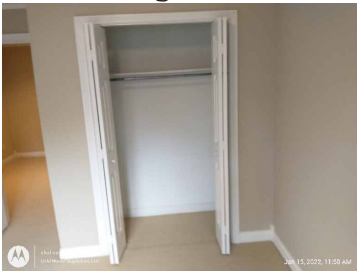
### Upper level center Bedroom

Closet: Large

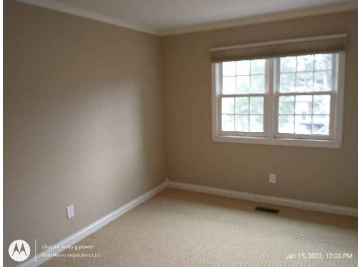
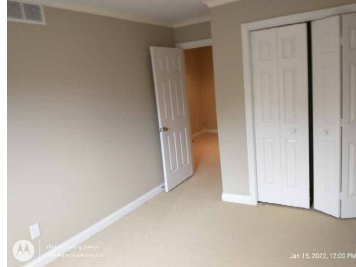
Walls: Paint

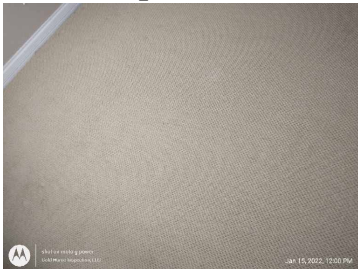
Floor: Carpet

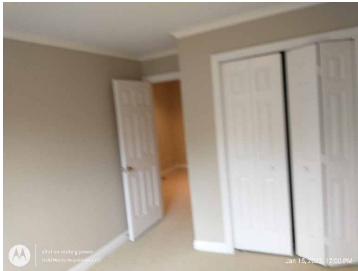
Doors: Hollow wood

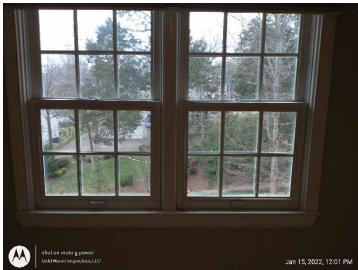
Windows: Wood double hung

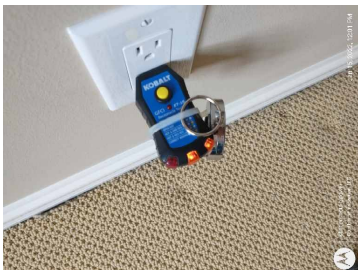
Electrical: 110 VAC GFCI

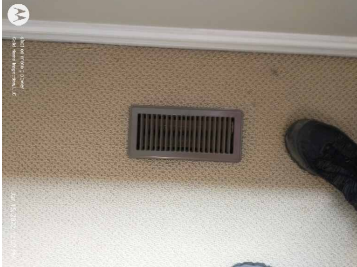
HVAC Source: Heating system register

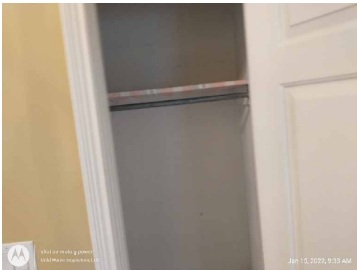
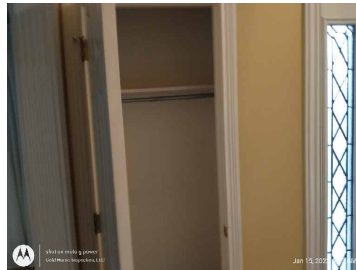
Living Room Living Space

Closet: Double small coat closet

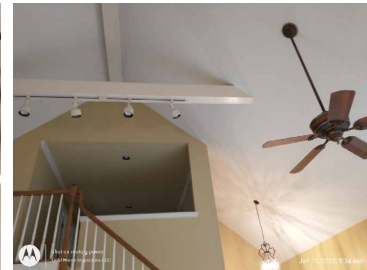
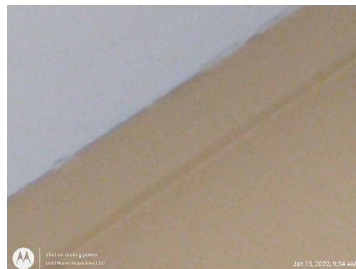
Ceiling: Paint

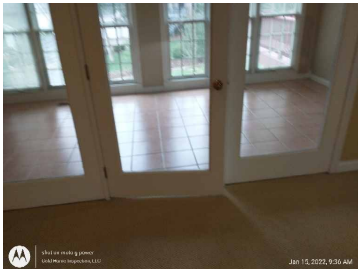
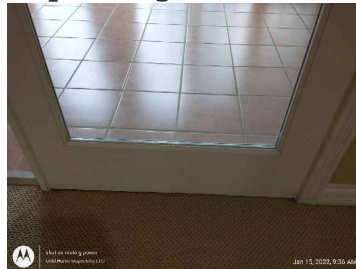
Doors: This should be tempered glass. Doors are not marked so.

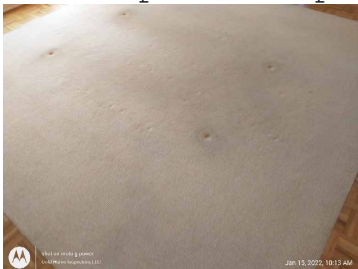
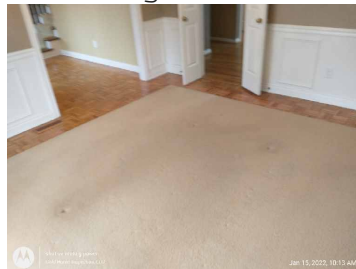
☒☐☐☐☐ Floor: Carpet - Carpet shows age

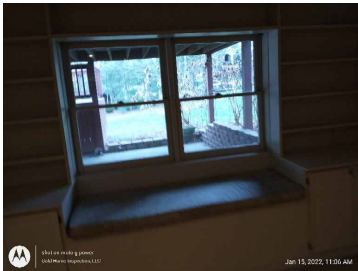
Windows: Wood double hung - The window will not open

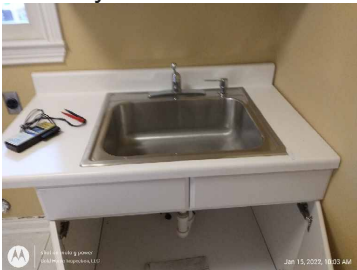
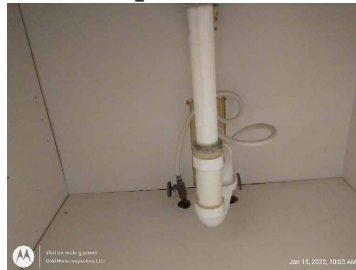
Laundry Tub: Wood - Counter top not mounted.

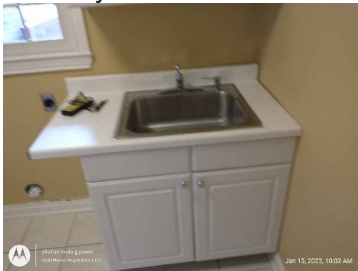
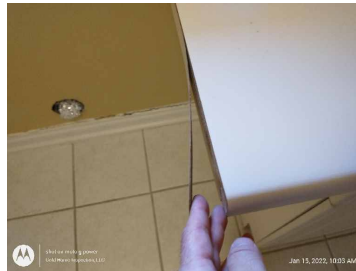
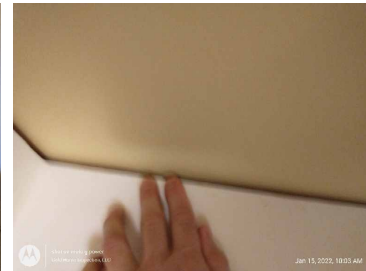
Laundry Tub Drain:

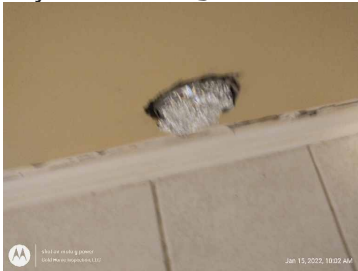
Dryer Vent: Rigid metal

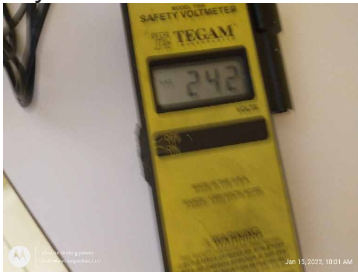
Dryer electric Line: 220

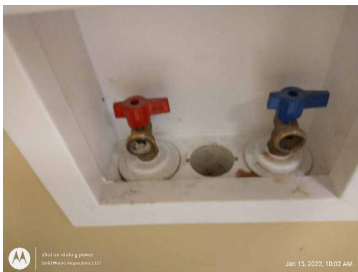
Washer Drain: wall mounted drain

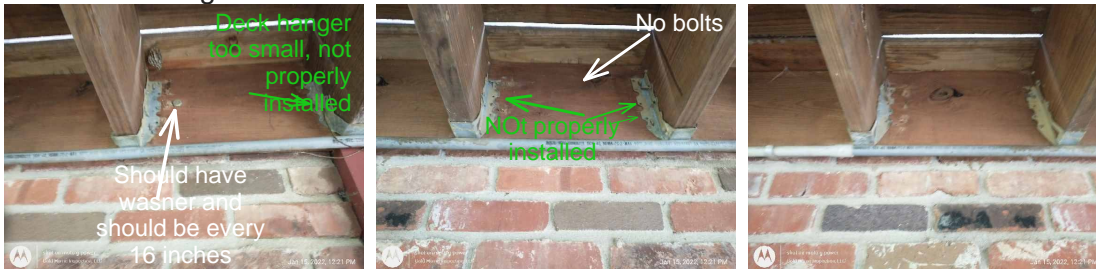
- 2. Main Deck Ledger Board:**

- 1. Main Deck Deck Boards:** Deck problems - Missing or wrong size deck hangers. Missing lag bolts, these 1/2 bolts are designed to hold a considerable weight, using small nails or bolts will lead to a failure. Missing ledger bolts and washers, repair using a board to try and support ledger board is not to code and will not work. Insured carpenter or handyman should repair the deck. Complete repairs will prolong the life of the deck. Decks are the number one source of home injuries.

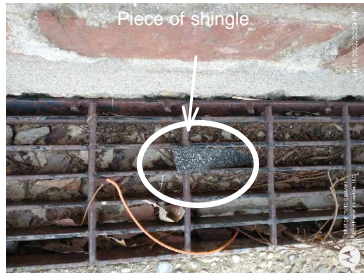
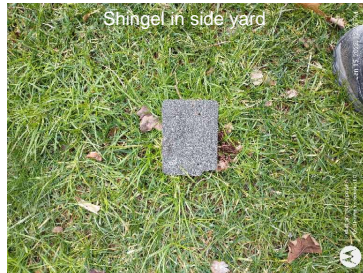
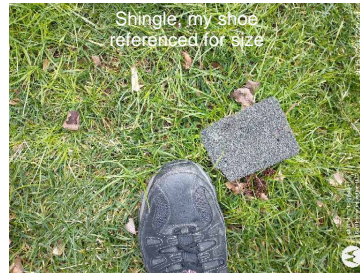
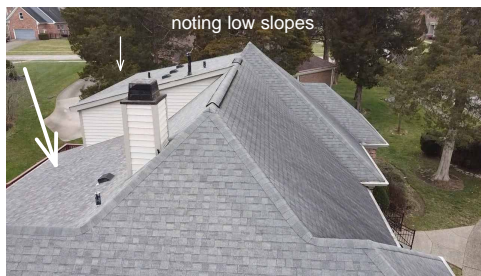
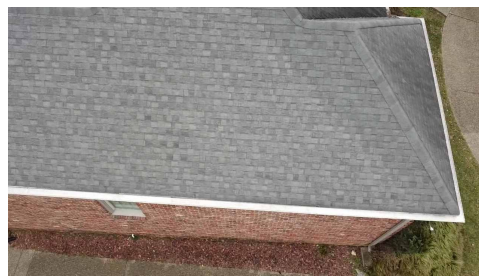
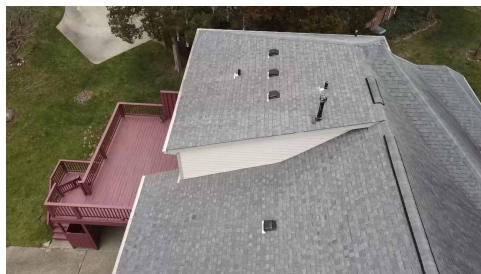
4. All Roof Surface Material: ROOF - Very difficult to estimate the age of the roof. We have pictures of shingles coming up on the front slope, above the living room windows, about five feet from the gutter. We have pictures of a small leak in the center bedroom. The ceiling in this room is painted white, while other second floor ceilings are painted yellow and this makes finding leaks very difficult. These issues should be repaired by an insured roofing contractor. We also have missing glandular and missing shingles, which we have pictures of, the roof should have had installed rolled roofing in the dead valley and over the second floor bedrooms. The roof is aging, has incorrect products installed and following recommendations from a roofing contractor, would be in the best interest of the purchaser.

FIREPLACE in living room - Should not be used until repaired.  
ROOF - Leak on second level and shingle coming off above living room window require repair. Recommend that roofer make recommendations required dead valley and flat area, along with recommendations for remaining life of roof.  
FURNANCE BLOWER - Recommend service call  
DECK - Requires repairs, failure to do so will cause more future problems and cost.  
WATER SERVICE NOT ON. Do to this no testing of hot water heater, drains, plumbing could be performed

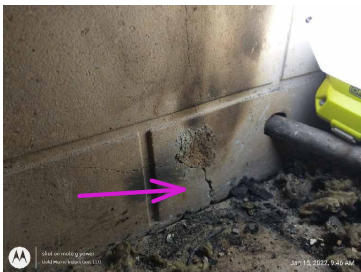
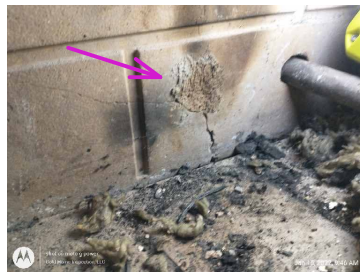
Smoke Chamber: Metal - Needs repair prior to use

9. Living Room Fireplace Smoke Chamber: Metal - Needs repair prior to use

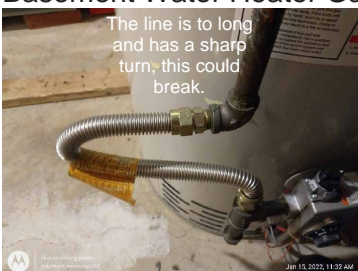
10. Basement Water Heater Gas supply line: Flex

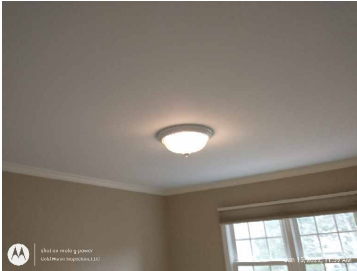
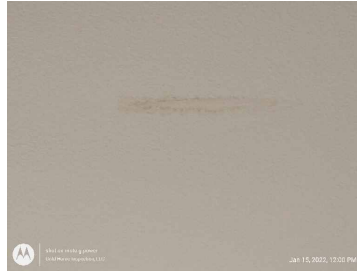
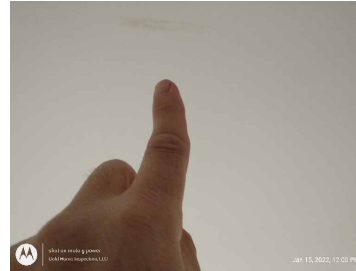
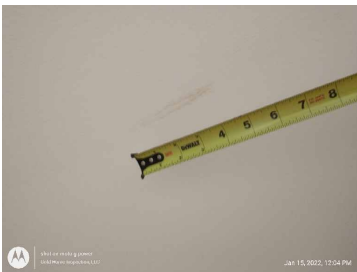
Ceiling: Paint - Water stains present. This will worsen until roof is repaired.

13. Upper level center Bedroom Ceiling: Paint - Water stains present. This will worsen until roof is repaired.

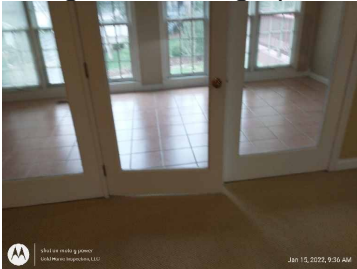
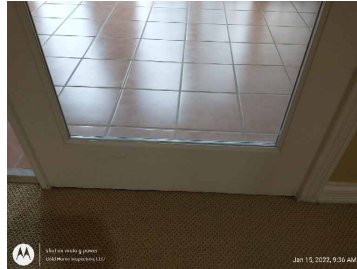
14. Living Room Living Space Doors: This should be tempered glass. Doors are not marked so.

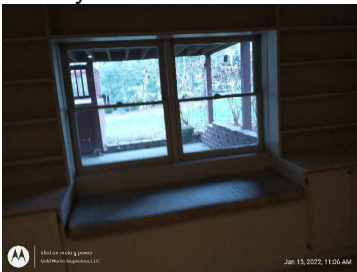
15. Family Room lower level Living Space Windows: Wood double hung - The window will not open

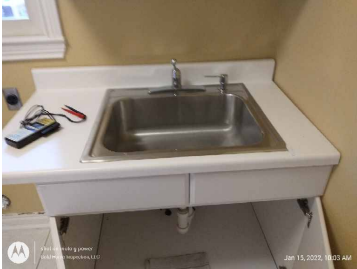
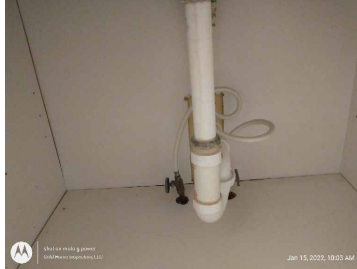
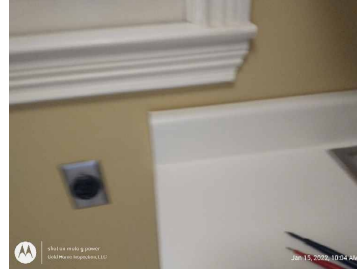
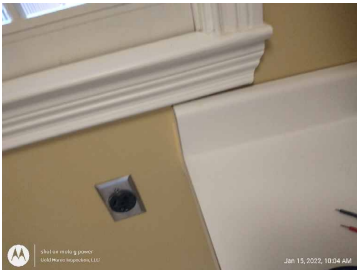
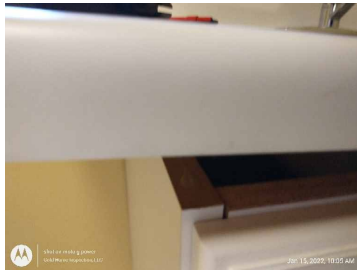
16. 1st Floor Laundry Room/Area Laundry Tub: Wood - Counter top not mounted.
